Technical Memo

Project: Durham York Energy Centre (DYEC)

Subject: **Covanta Phase 1 Completion and Recommendation for Boiler #1 Restart**

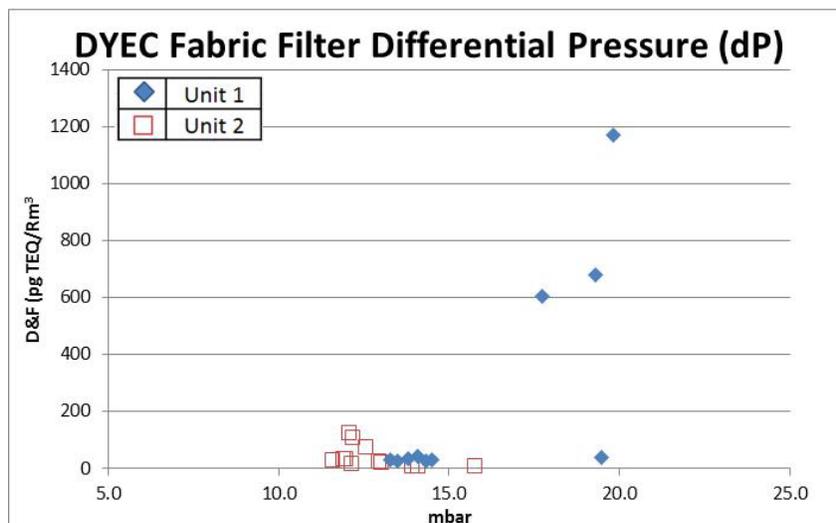
Figure 1

HDR is also in agreement that the high fly ash buildup in the 2nd/3rd pass hopper and the baghouse issues are two of the most probable causes of the high emissions of D&F. A graph of the fabric filter differential pressure (dP) data from all D&F testing to date is shown in Figure 1. As seen in the graph, the higher D&F results were measured when the fabric filter dP was at the highest. There are many factors associated with this variable and this graph alone is not intended to show a direct correlation.

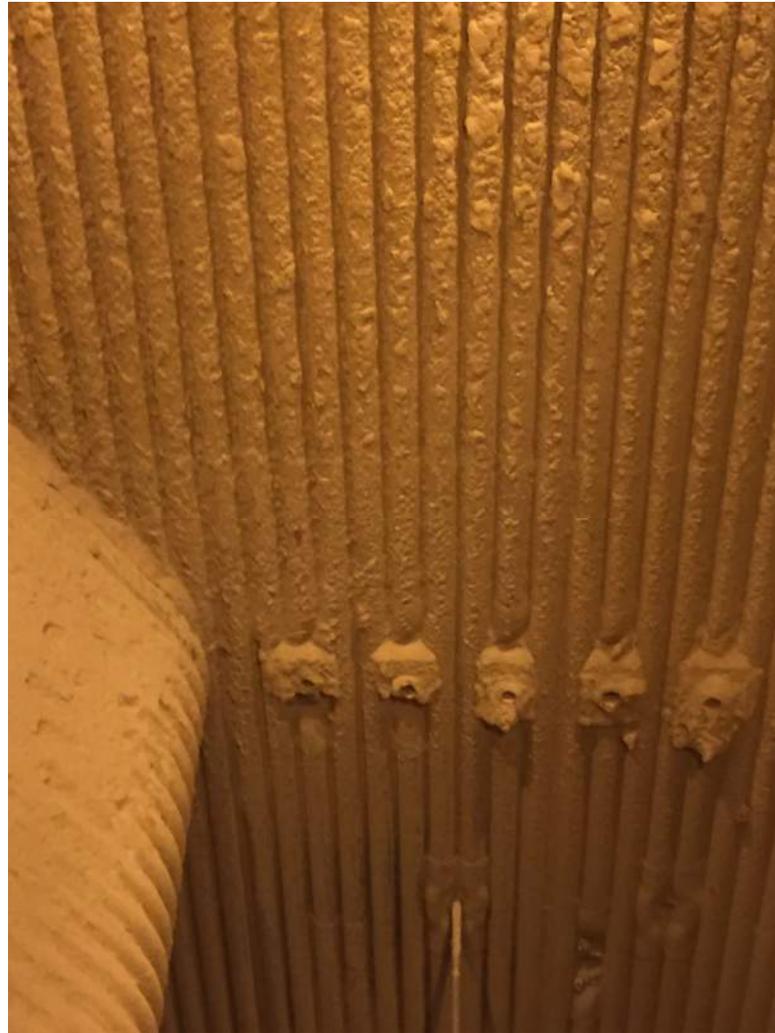
Photo 2 – Boiler 1st Pass – IGR Nozzles

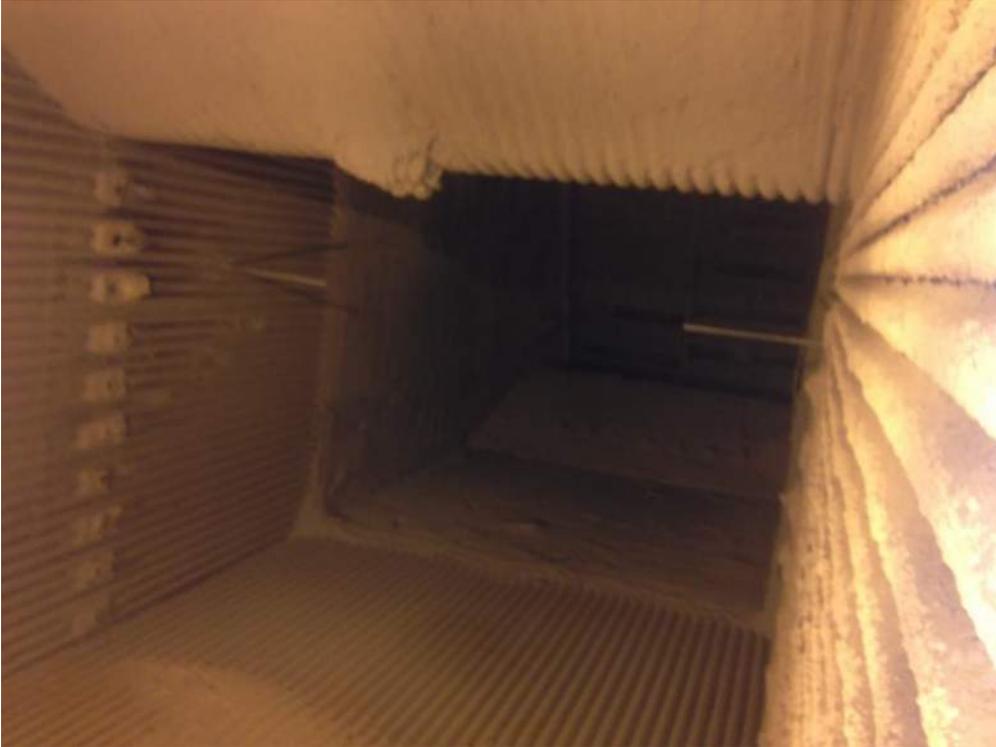
Photo 3 – 1st Pass Small Build Up on Bullnose

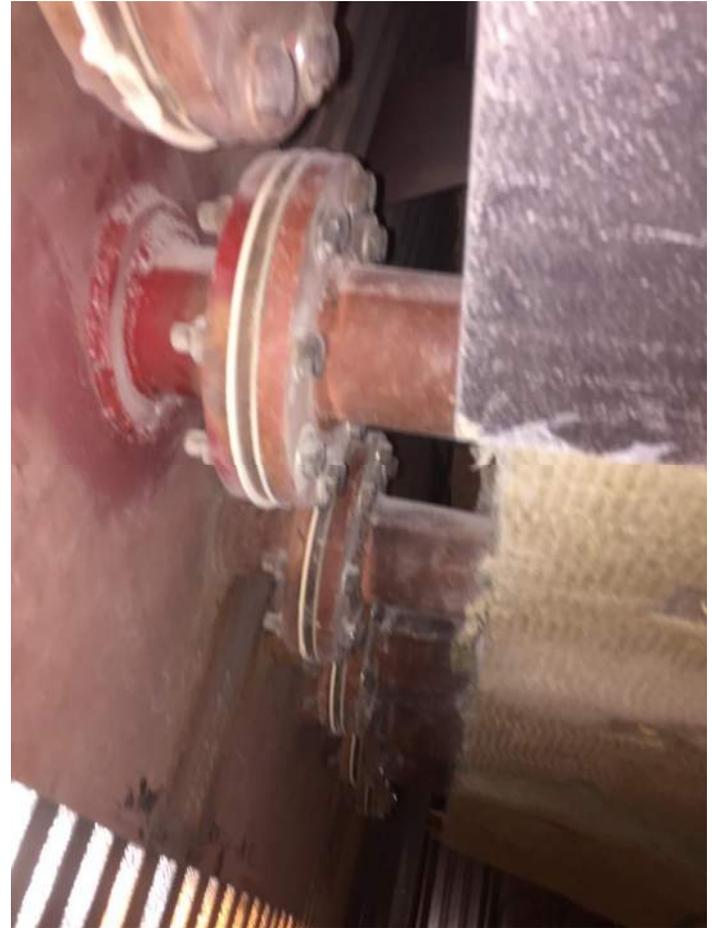
- Two (2) of the ten (10) NO_x Reduction System Internal Gas Recirculation (IGR) nozzles on the right side of boiler #1 were plugged (see Photos 4, 5 and 6 in Attachment 3). These nozzles are alternating sizes of 40 mm and 55 mm. Boiler #2 nozzles are 40 mm and 70 mm. There may be some slight impact of the plugged nozzles on carbon monoxide (CO) or combustion control with the two (2) configurations. Covanta's Corporate engineers are planning to monitor composition of the IGR gases during Phase 2. HDR will continue to review and monitor these activities.

Photo 4 - IGR Nozzles – Boiler Sidewalls

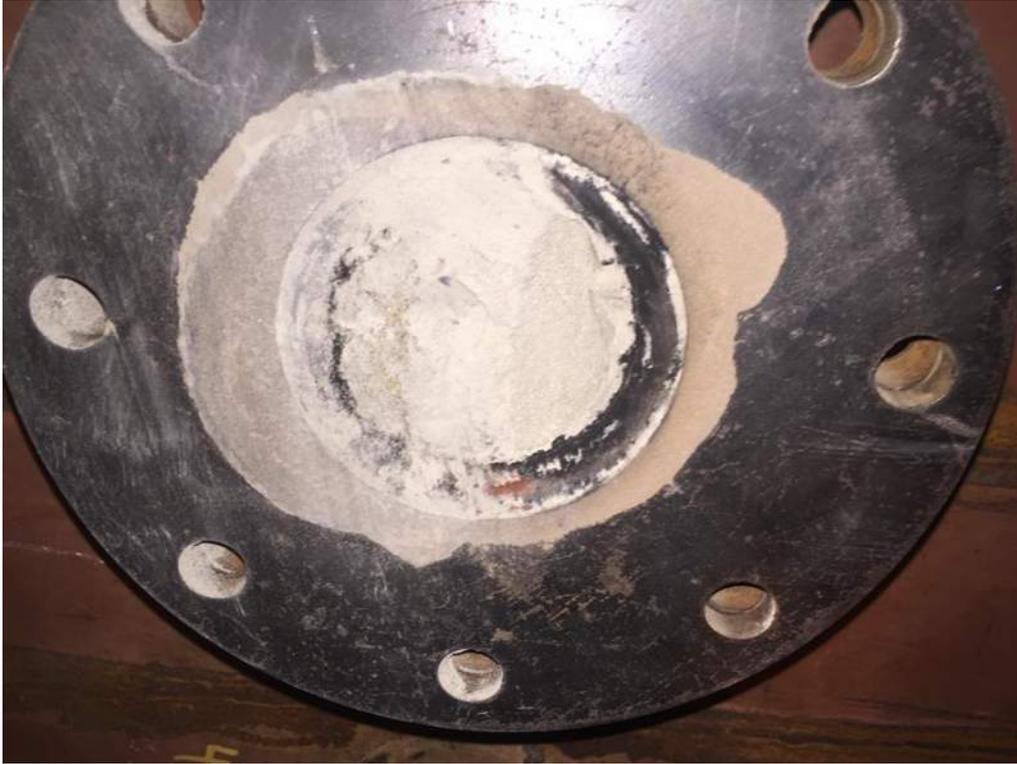
Photo 5 - Plugged IGR Nozzle

| TASK | NOTES | HDR NOTES |
|---|---|--|
| 24 remove IGR nozzle elbows and ensure nozzles are clear; | 2 blocked nozzles found on west side (#2 and #3); both were unplugged | |

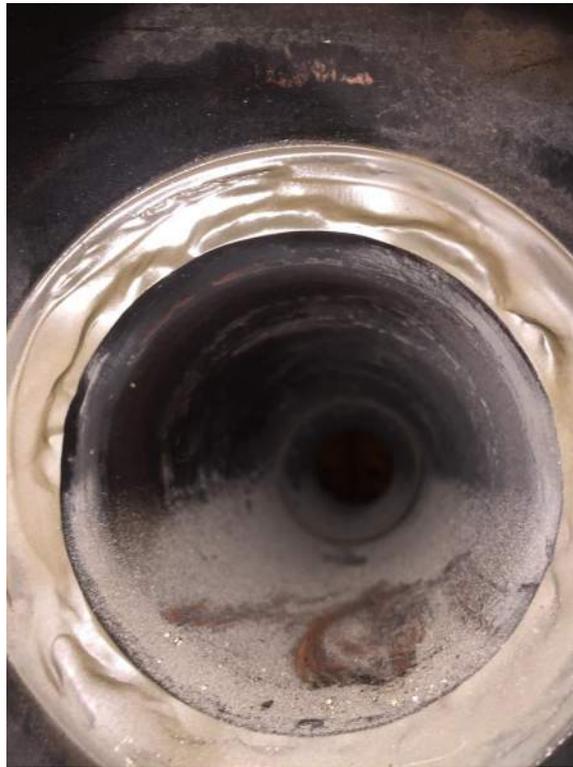
Photo 6 - Clear IGR Nozzle

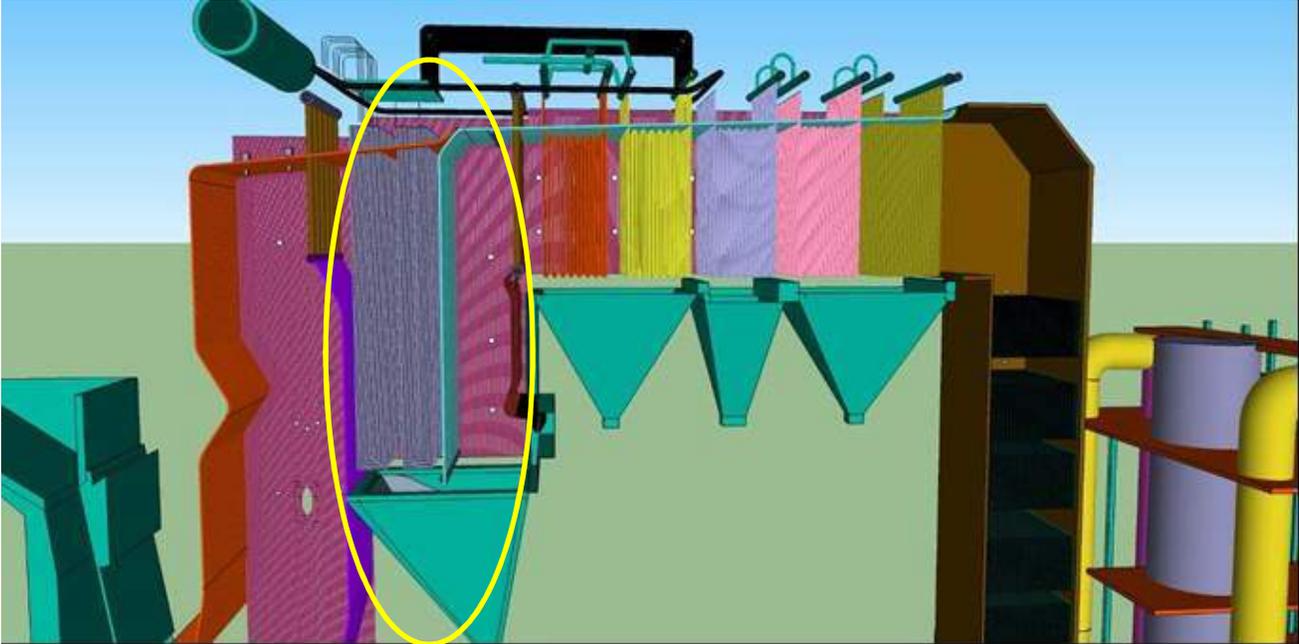
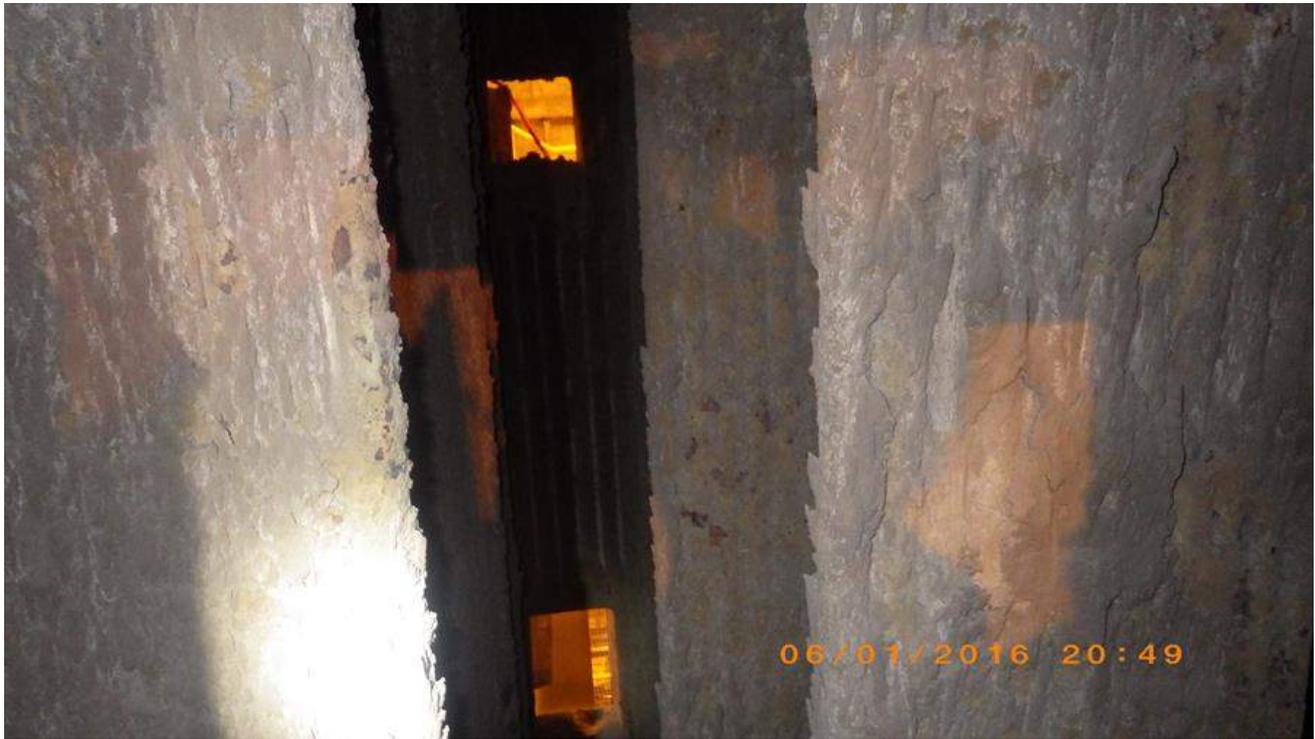
- Buildup on the boiler #1 tubes appeared typical of other similar boilers based on the current point in the operating campaign. Therefore, this buildup does not appear to be a contributor to the D&F exceedance in boiler #1. No staging or access into the boiler was provided, so HDR performed all inspections externally. (see Photos 7 through 12 and Photos 14 through 18 in Attachment 3)

Photo 7 - 2nd Pass Superheater Platens.

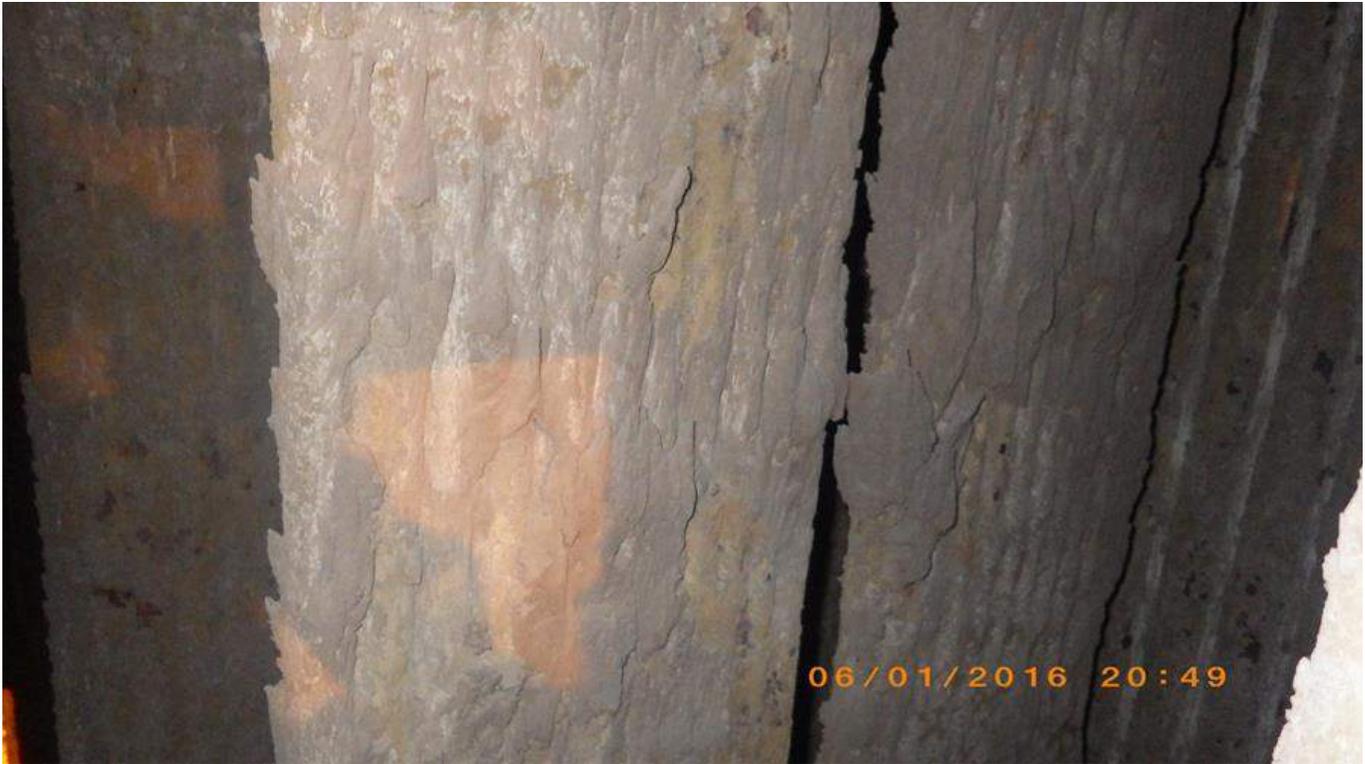
Photo 8 - Second Pass Superheater Platen – Expected Fouling

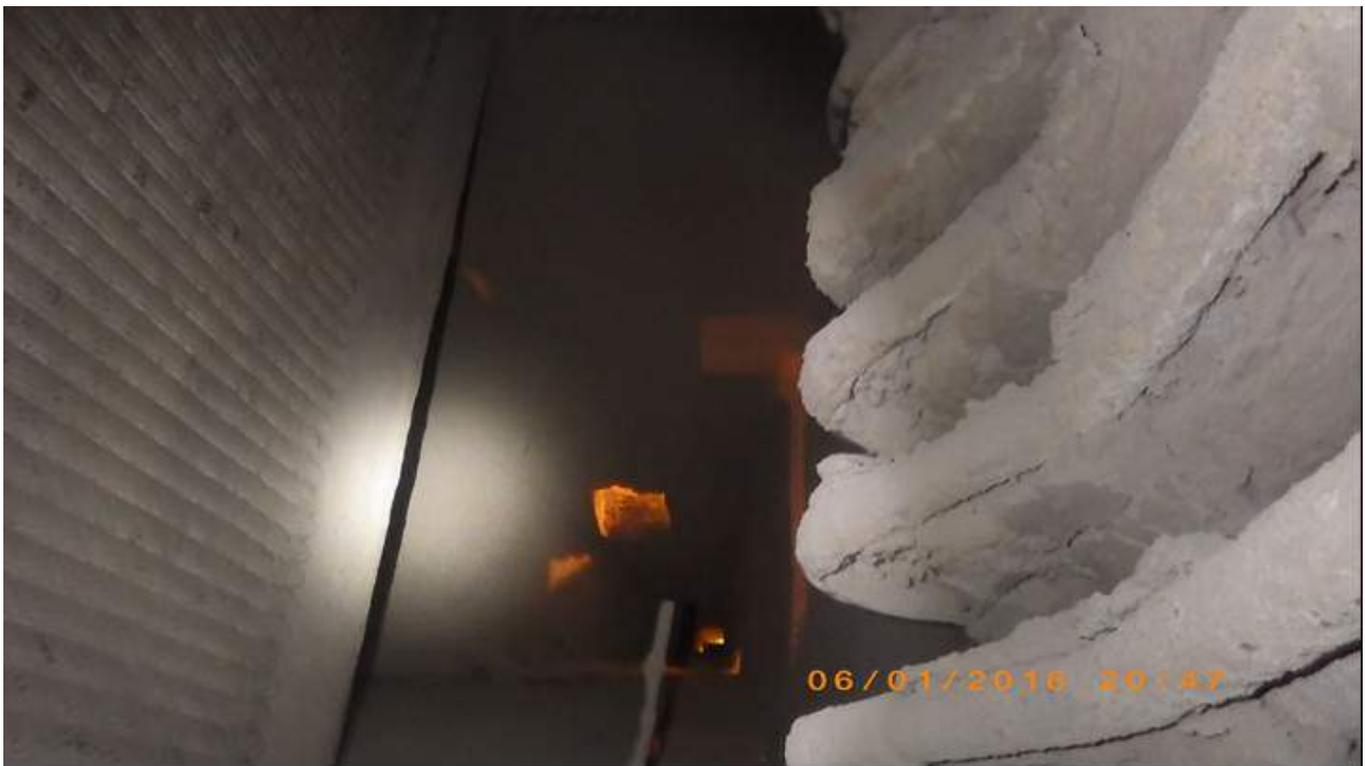
Photo 9 - 3rd Pass Rear wall – Loops from Convective Zone Removal on Rear Wall (left side of photo)
Hopper Clear (At bottom)
No Fouling on Front Wall

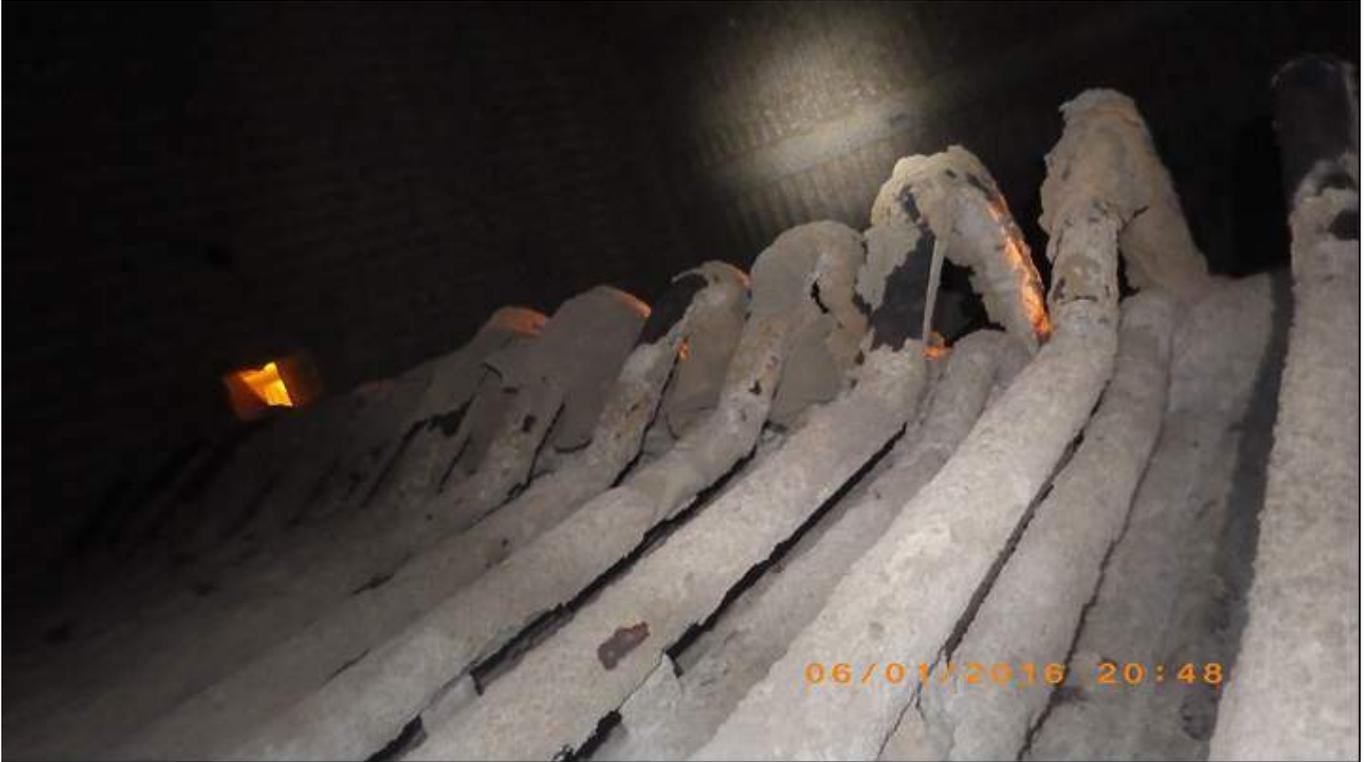
Photo 10 - 3rd Pass Convective Zone Bypass Loops – Looking Up

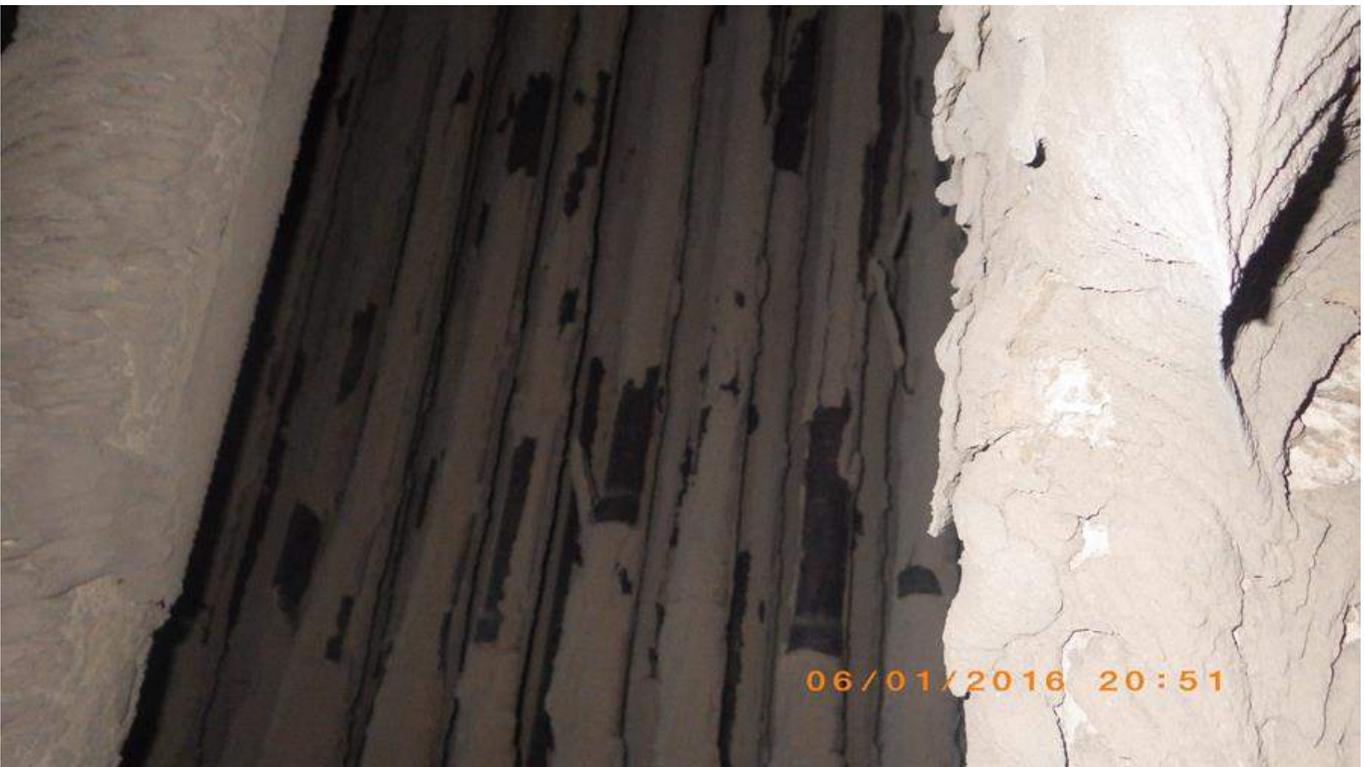
Photo 11 - Upper 3rd Pass – View Looking into Superheater – Screen Tube Fouling Heavy Near Door

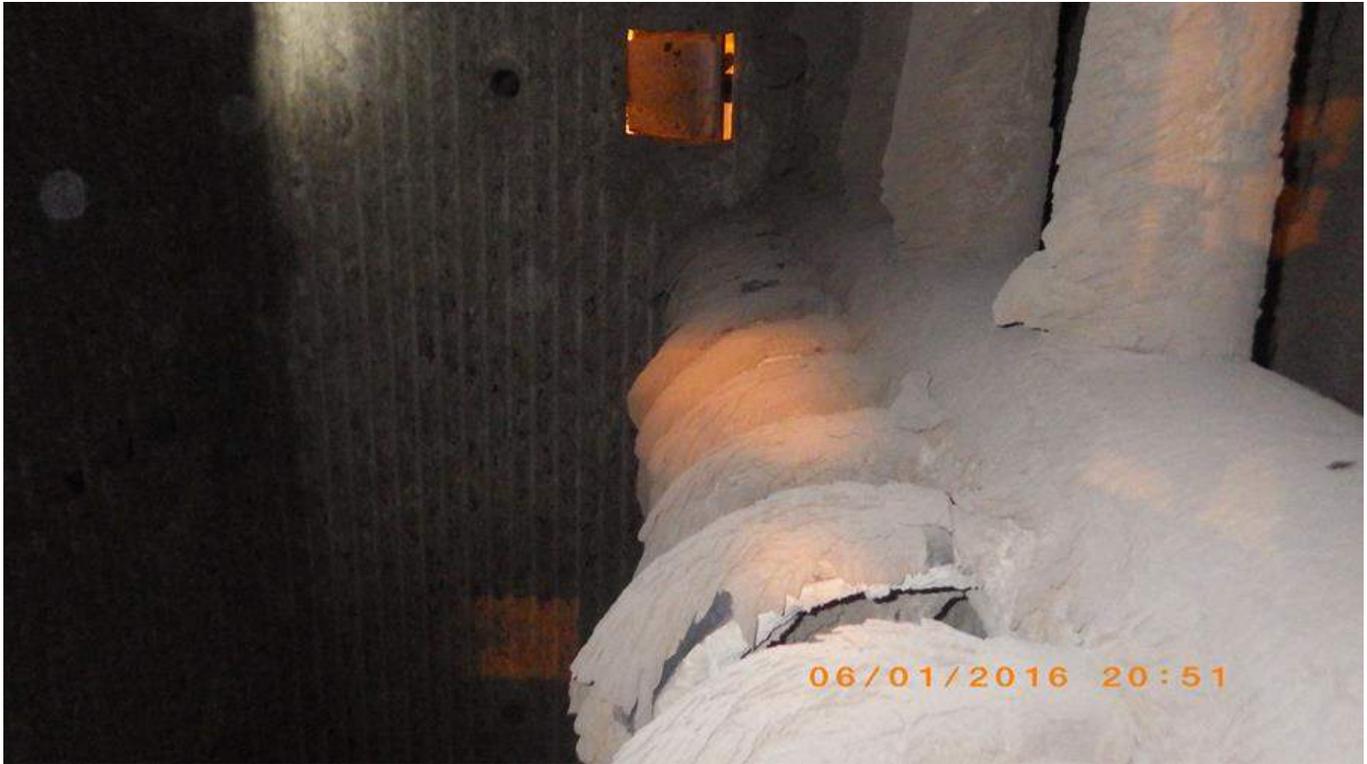
Photo 12 - Top of 3rd Pass – Header at Bottom of Screen Tubes

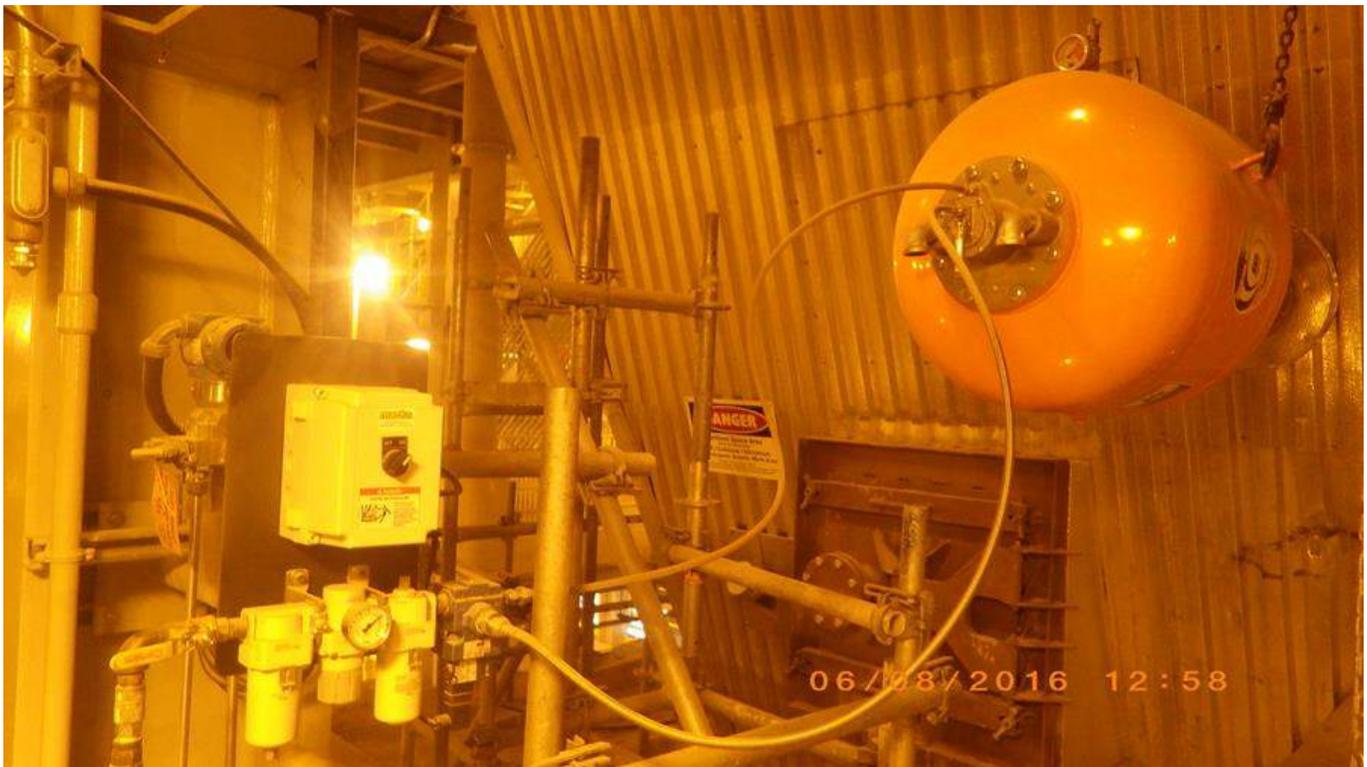
- Air cannons have been installed on the sloped wall of the 2nd pass hopper on boiler #1 and boiler #2. The air cannons are designed to release a large pulse of air into a strategically placed nozzle in the hopper to disturb any buildup and aid in emptying the hopper. The air cannons on the 2nd pass are currently operational on boiler #2 and will be operational on boiler #1 when the unit restarts. Covanta has a plan for the initial settings for the air cannon and will monitor the performance and adjust the settings as deemed necessary. This will assist in eliminating plugs in the 2nd pass hopper. During Phase 2 Covanta will be investigating the need for additional air cannons or relocating the current air cannon to be more effective.

Photo 13 - Air Cannon In Hopper Under 2nd/3rd Pass

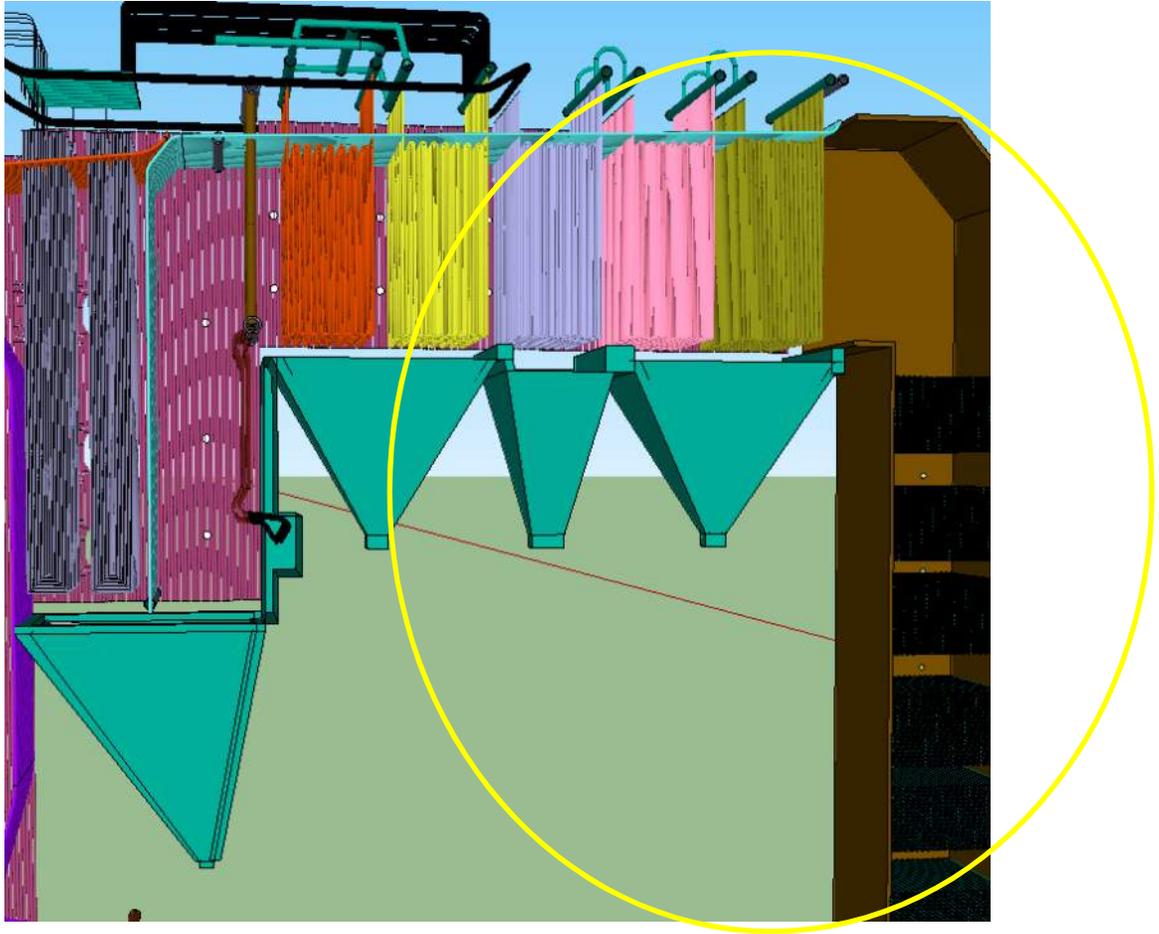
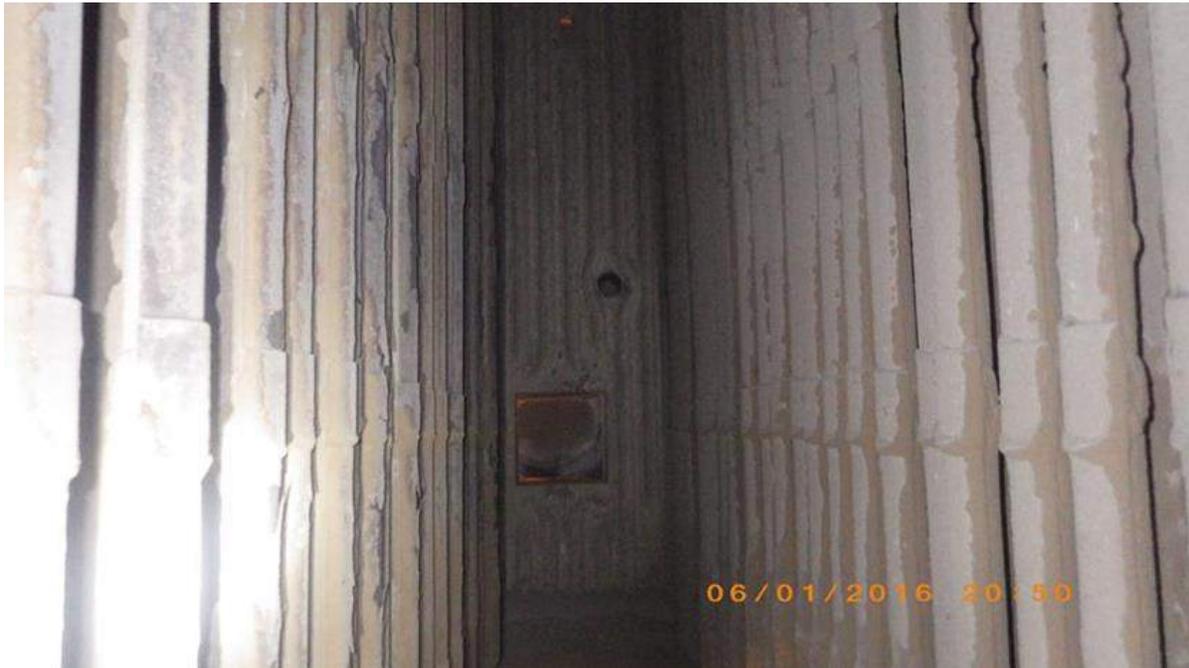
Photo 14 - View Between Superheater Sections – Fouling Typical

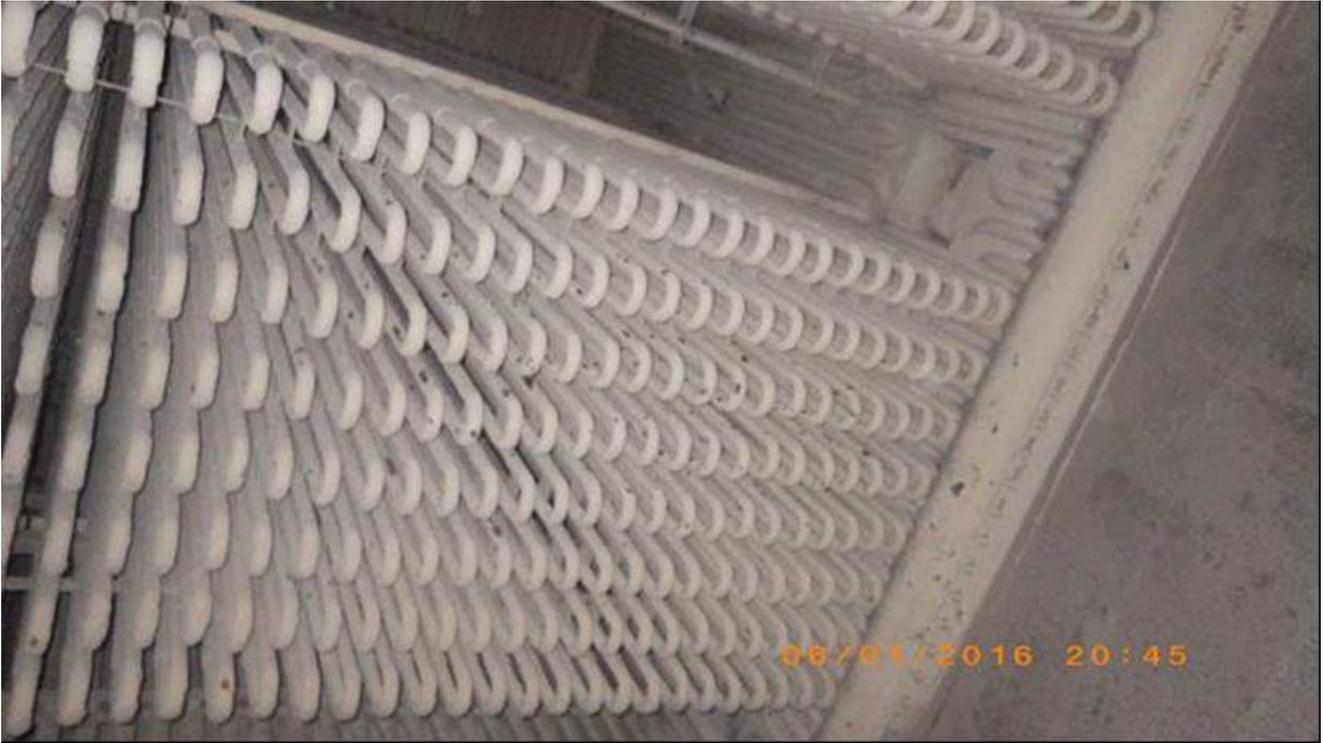
Photo 15 - View Up From Hopper Looking at Superheater Bottom Loops – Fouling Normal to Low

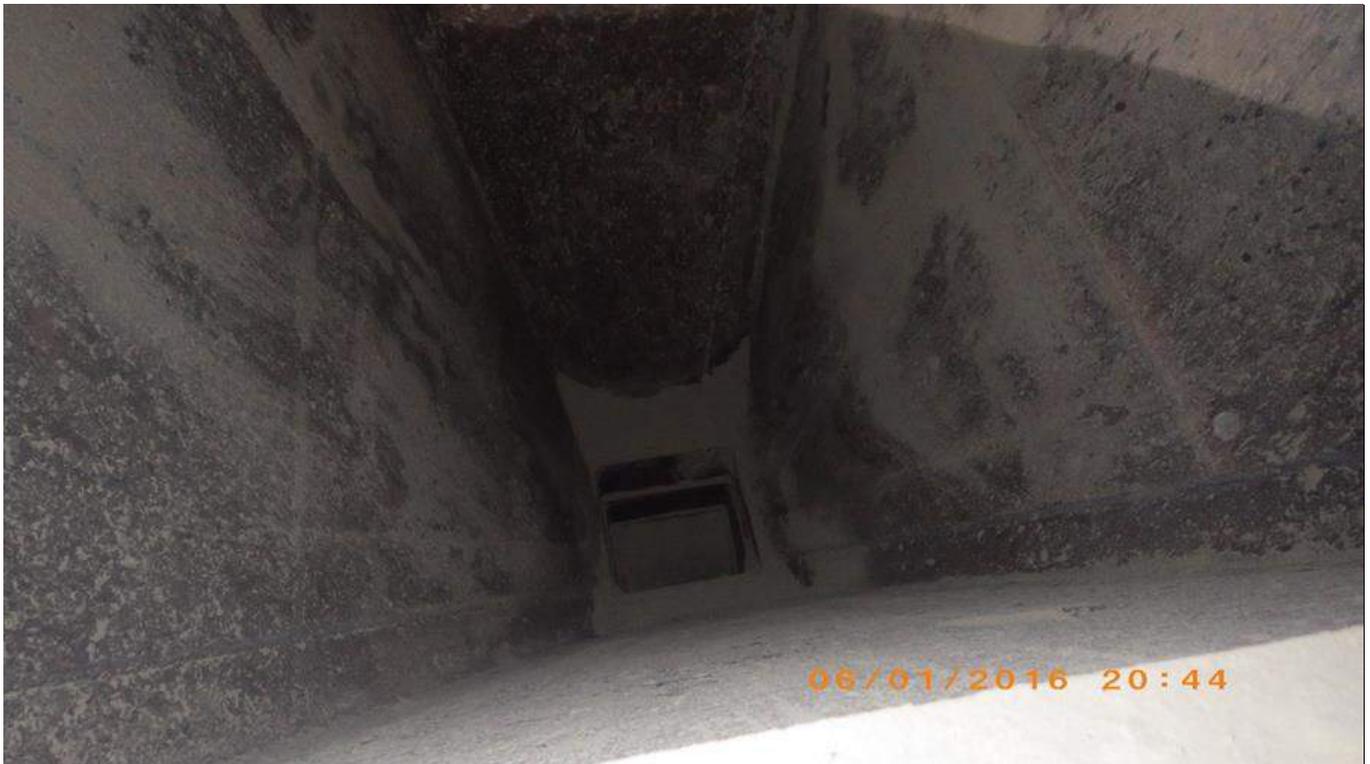
Photo 16 - Hoppers under Superheater Sections - all Clear

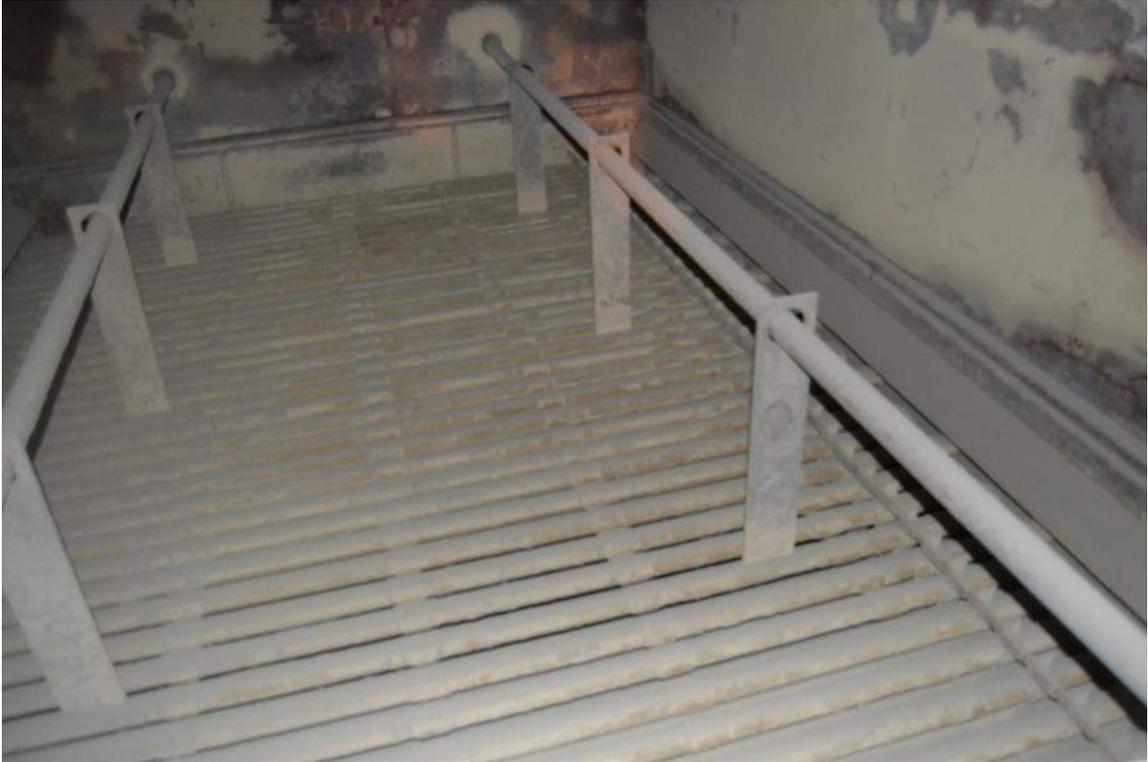
Photo 17 - Inlet to Economizer – No Excessive Fouling Noted from Above

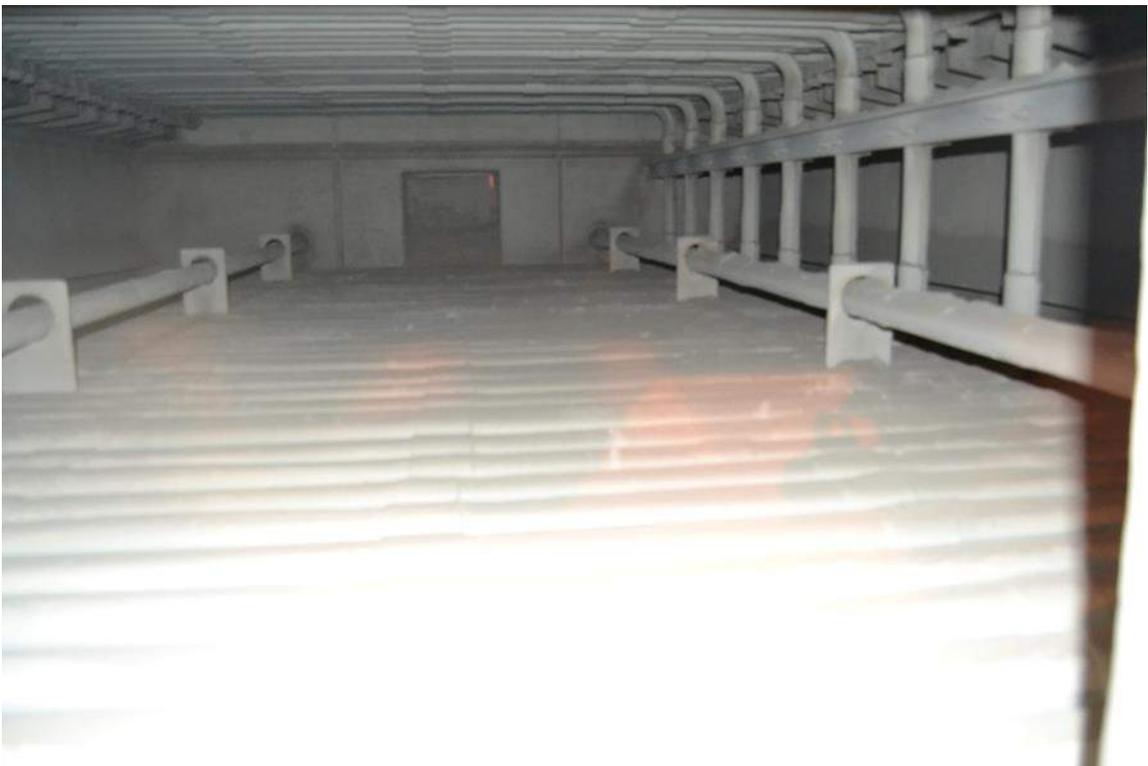
Photo 18 - View Between Economizer Bundles – No Excessive Fouling Apparent

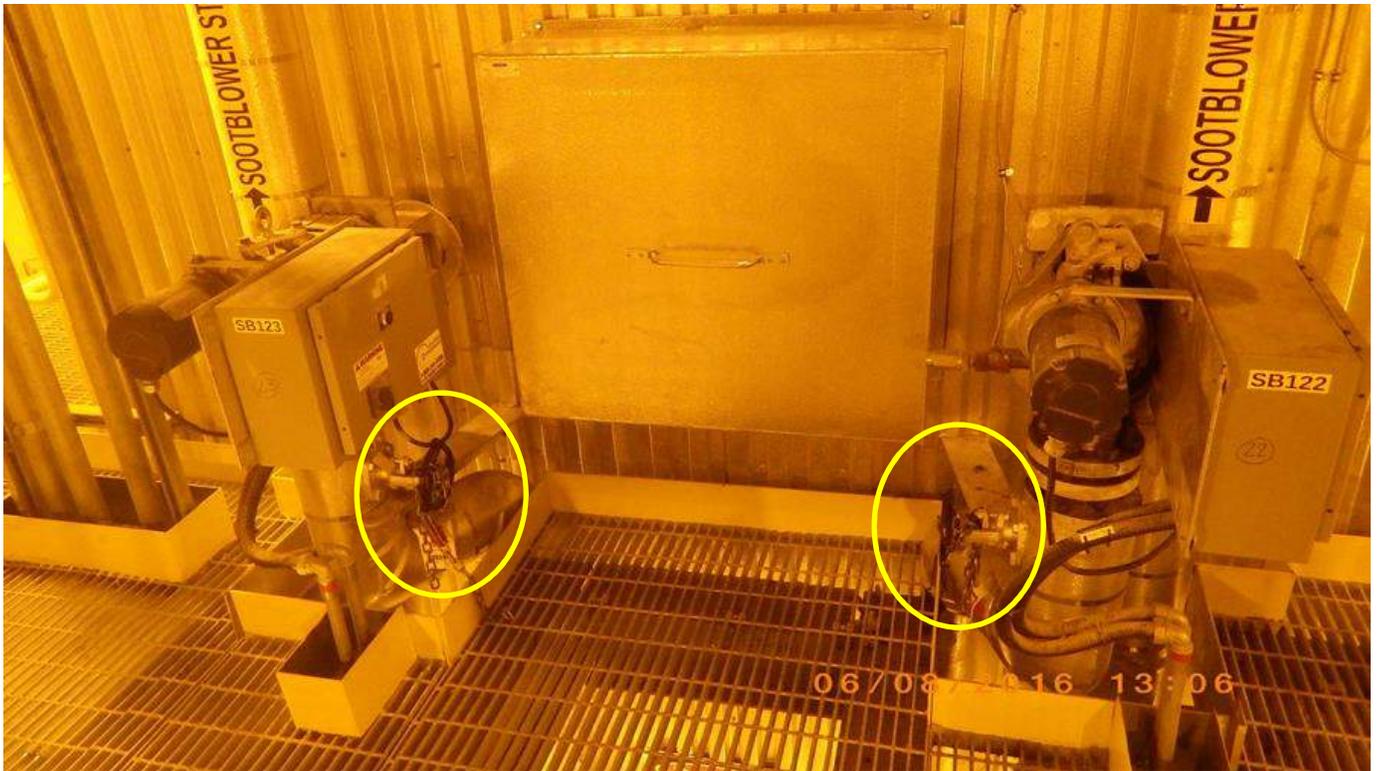
- Economizer sootblowers 122 and 123 were found to have broken lances. This would render the sootblowers ineffective in this area and could cause damage to tubes. While it is possible that blowing uncontrolled steam into this section could have an impact on emissions, it would not be expected to be significant. The lances have been repaired. Currently the steam is isolated to these sootblowers (see Photo 18 in Attachment 3). HDR will monitor the full sootblowing sequence with Covanta during startup of boiler #1.

Photo 18 - Economizer Sootblowers 122 and 123 – Lances Repaired but Steam Remain Locked Out
HDR to monitor during startup)

| TASK | NOTES | HDR NOTES | |
|--|--|--|---|
| 51 | run rotary blowers and verify alignment | repaired broken lances on economizer SB's 122 and 123; SB 129 broken drive; parts expected 2 wks (SB129 will have no effect on facility operations or emissions) | SB 122 and 123 broken shafts - reviewed latest SB rounds Inspections - |

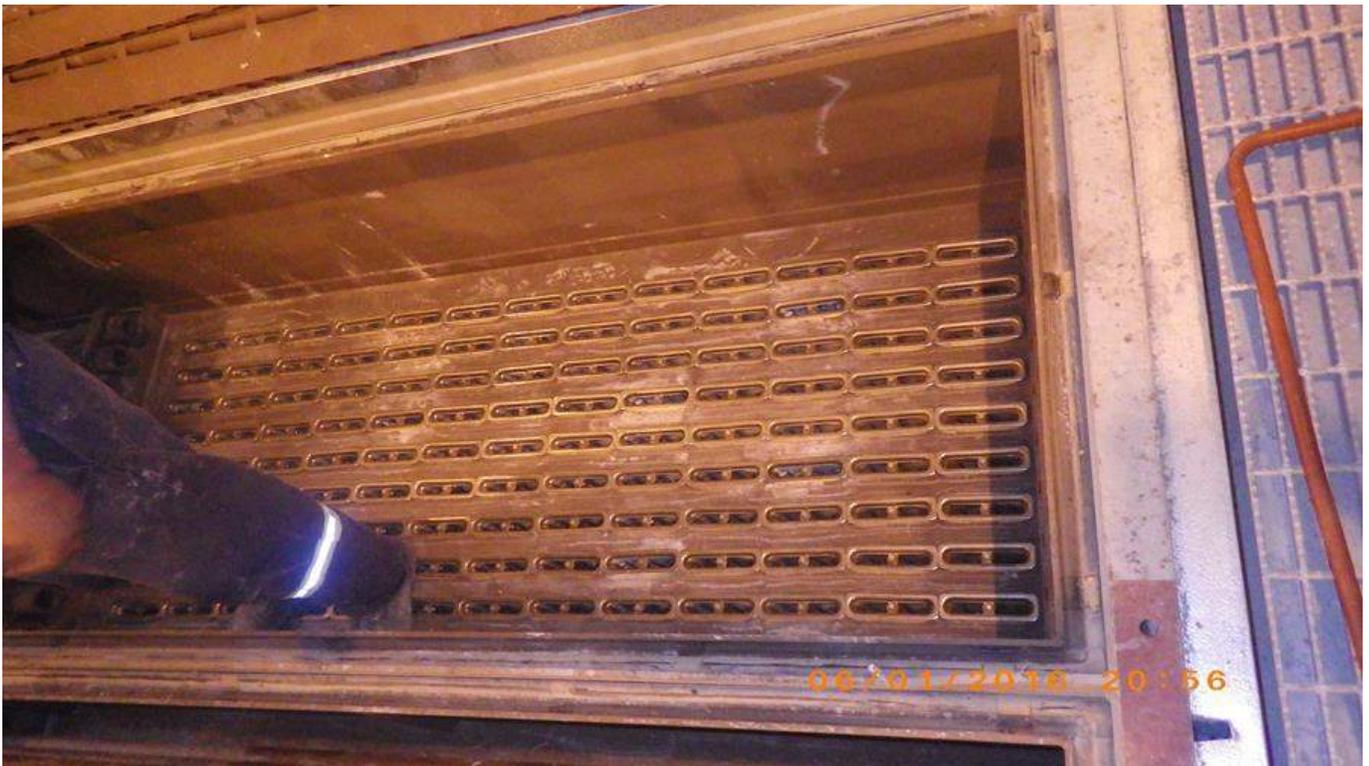
- a. There were numerous bags that were bridged and plugged and may have contributed to degraded baghouse performance. (See Photos 19 through 26 in Attachment 3) Approximately 93 filter bags were replaced by Covanta during the outage (out of a total of 1560 bags). Only one bag was found to have a small hole, and the remaining 92 bags were replaced as a precautionary measure. A Visolite test (a tracer method that uses a fluorescent powder and a blacklight to detect bag leaks) was performed to verify that no other bag leaks were present.

Photo 19 - Baghouse Tube Sheet – Dust Indicates Bags in That Area Have Been Pulled for Replacement or Inspection

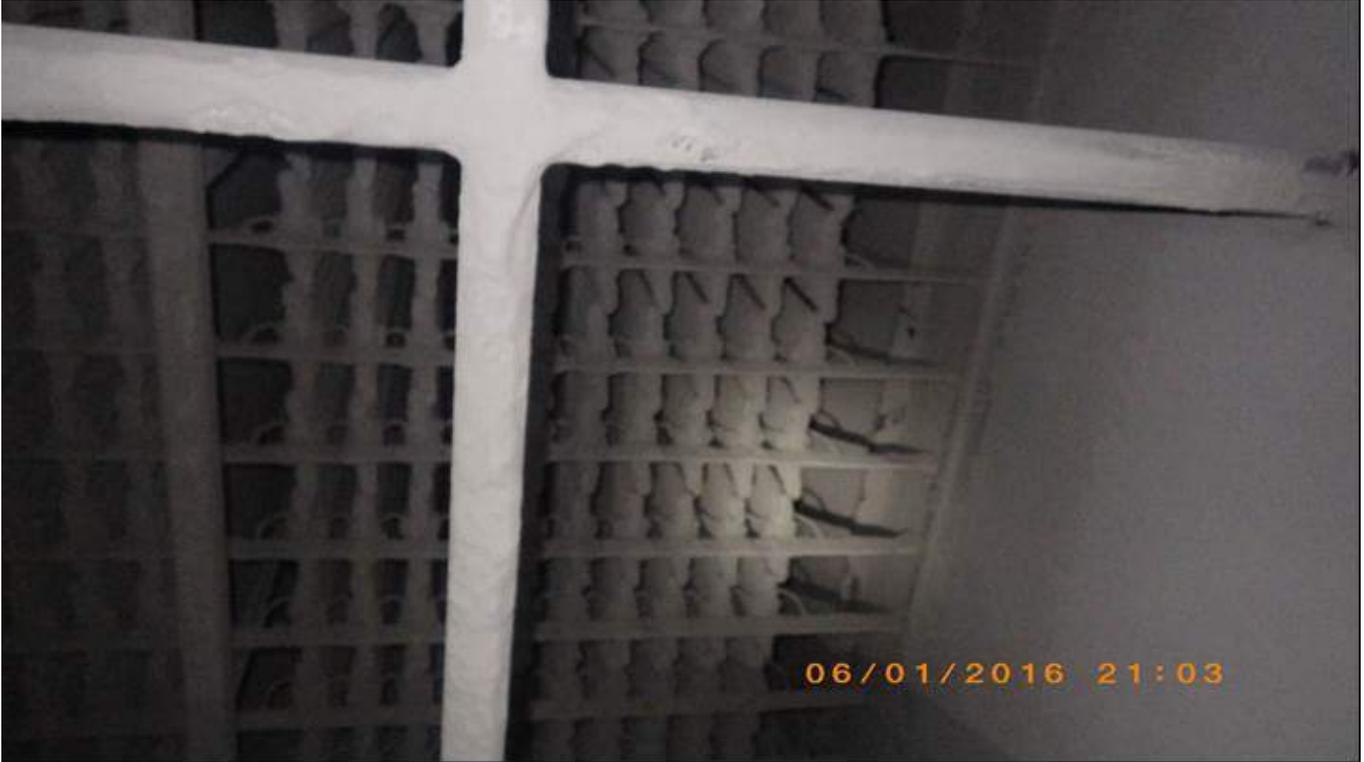
Photo 20 - Looking up into Baghouse Bags -
