Technical Memo

Project: Durham York Energy Centre (DYEC)

Subject: **Covanta Phase 1 Completion and Recommendation for Boiler #1 Restart**

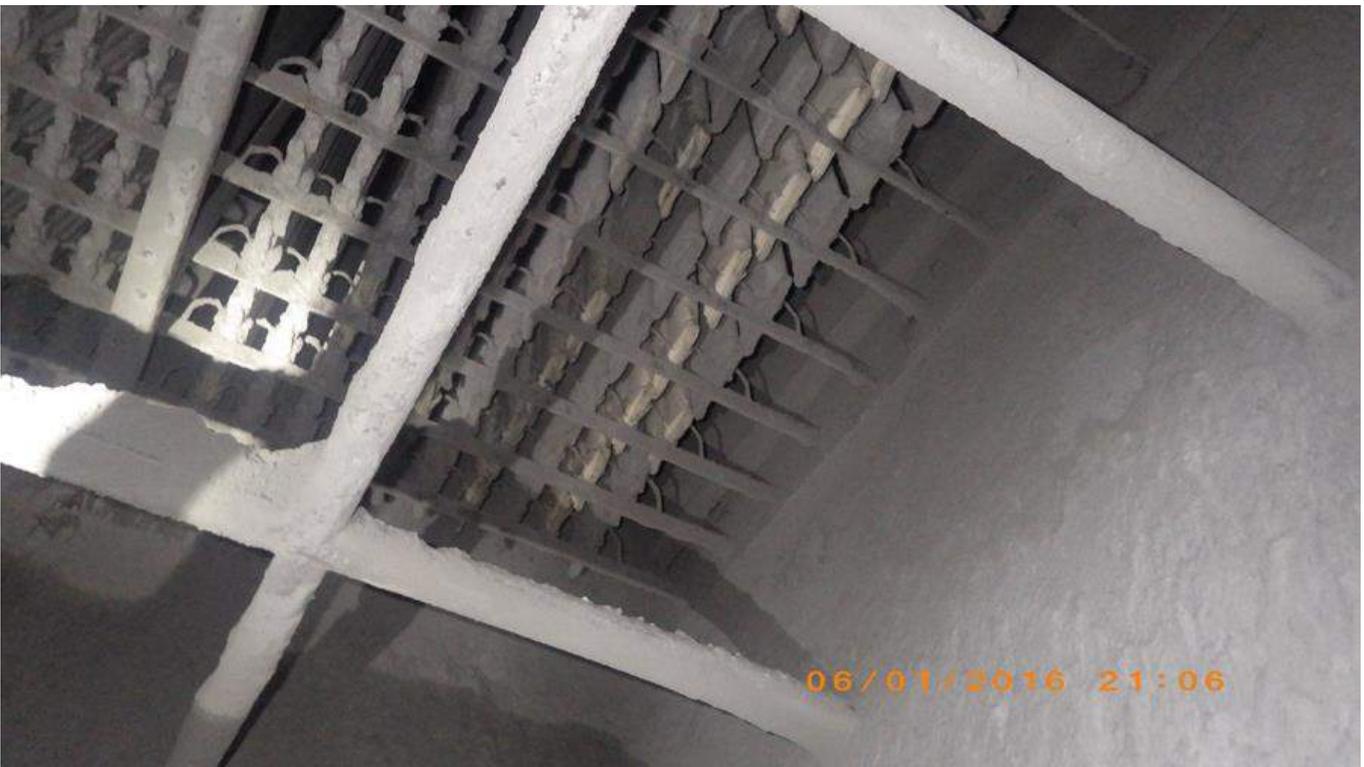
- a. There were numerous bags that were bridged and plugged and may have contributed to degraded baghouse performance. (See Photos 19 through 26 in Attachment 3) Approximately 93 filter bags were replaced by Covanta during the outage (out of a total of 1560 bags). Only one bag was found to have a small hole, and the remaining 92 bags were replaced as a precautionary measure. A Visolite test (a tracer method that uses a fluorescent powder and a blacklight to detect bag leaks) was performed to verify that no other bag leaks were present.

Photo 21 - Bottom of Baghouse Bags – Replaced bags are Evident

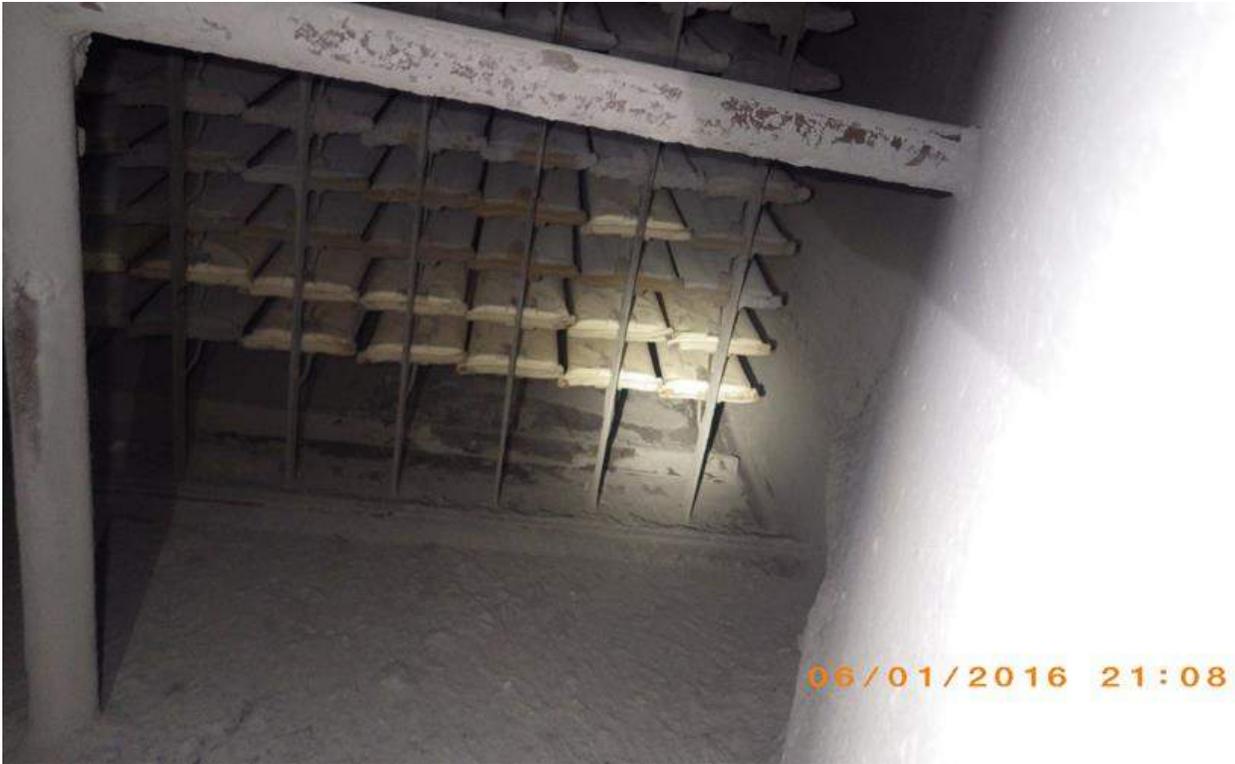
Photo 22 - Bags Replaced in Baghouse 1

| TASK | NOTES | HDR NOTES | |
|---|---|---|---|
| 70 | Inspect fabric filter bags and change out as required | 93 bags changed and 15 cages; Kuttner rep on site June 1 to assess baghouse; observed some pluggage in bags; see map. | 93 Bags replaced - one small hole identified - ptfе coated fibers versus ptfе membrane - membrane may provide superior filtration and may provide operational benefits |

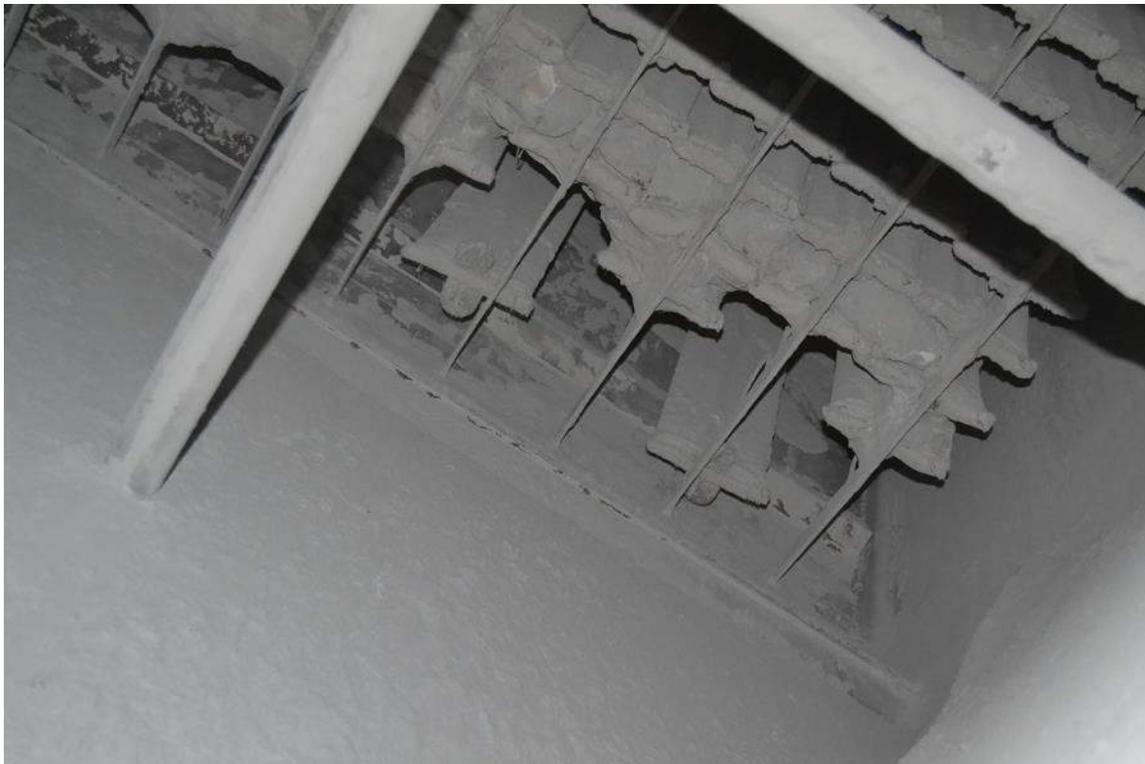
Photo 23 - As Found Condition of Unit #1 Bags – Out of Position

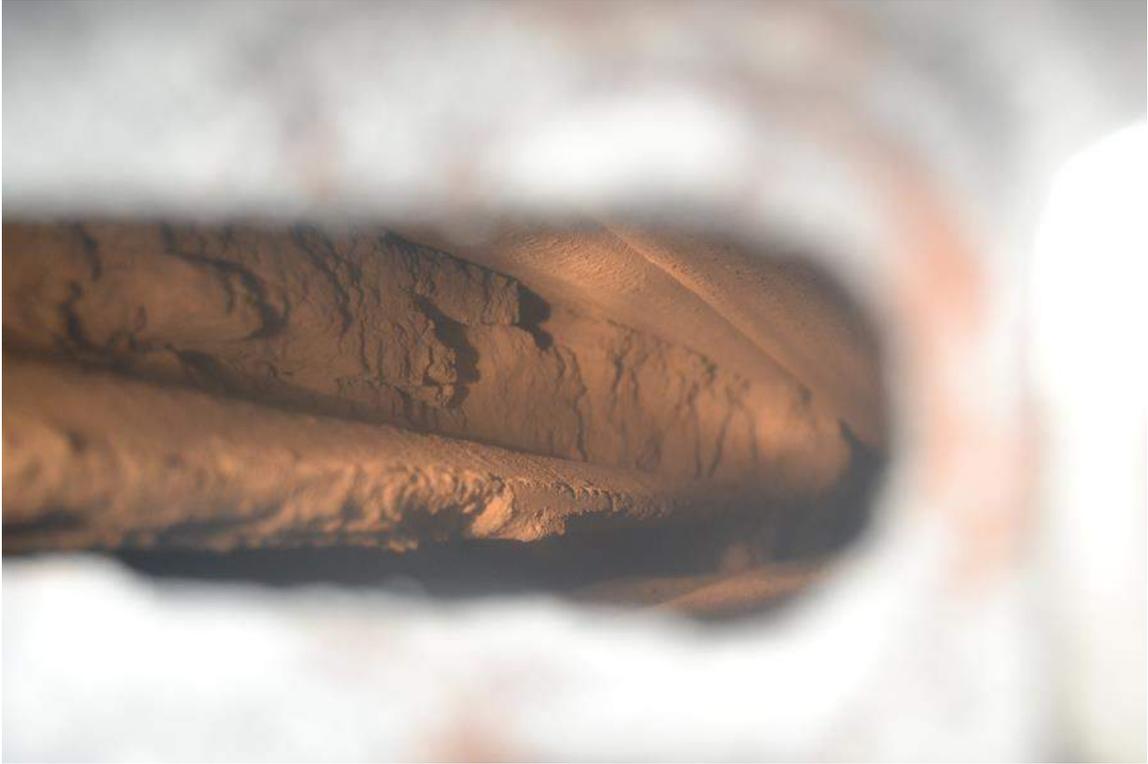
Photo 24 - View Looking Through Hole in Tubesheet – Shows Plugging Between Bags – NOT TYPICAL

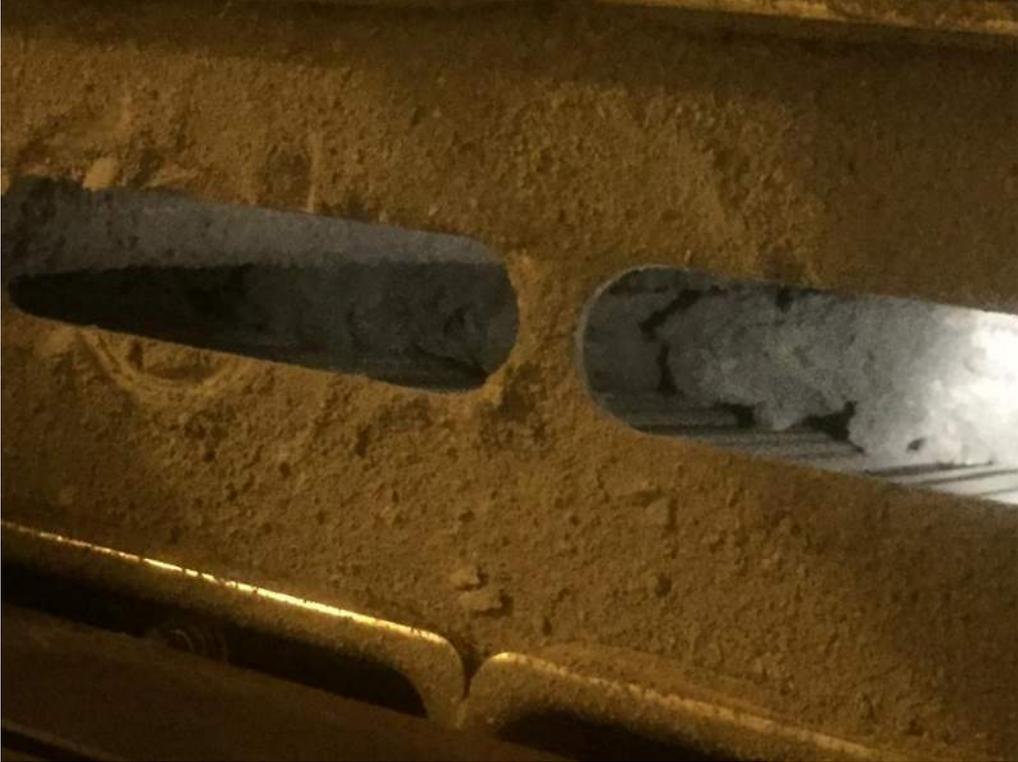
Photo 25 - View of Buildup Between Bags – NOT TYPICAL

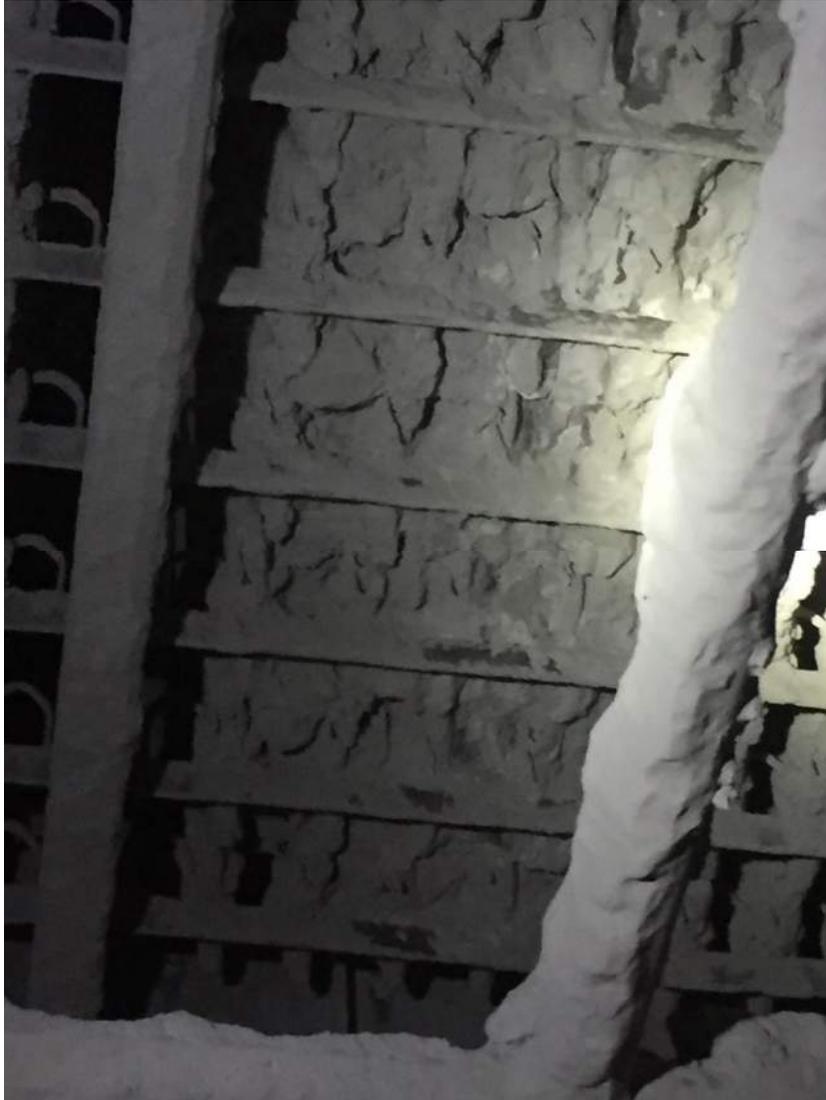
Photo 26 - View up at bottom of Bags – Fouled
Build up That Appears to Have Formed When Moist or Wet (NOT TYPICAL)

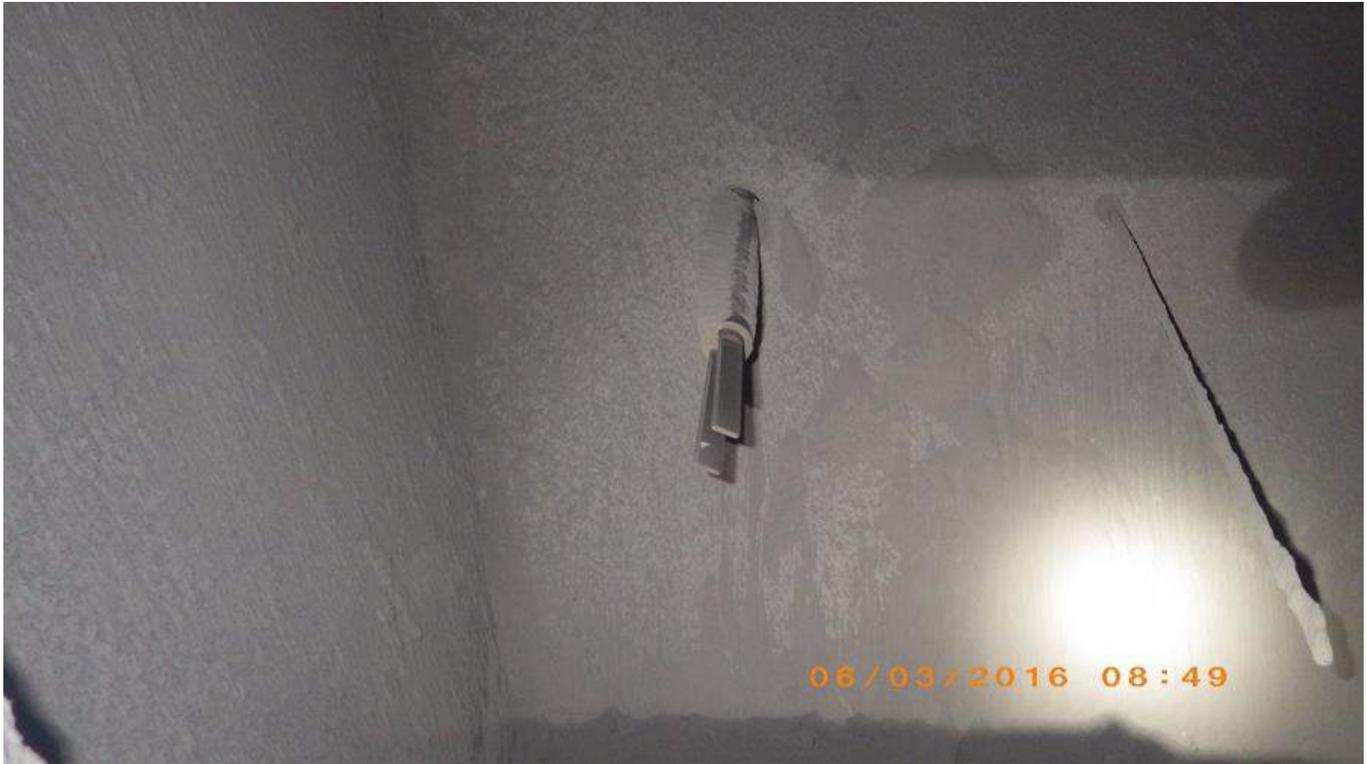
- The orientation of the hopper level probes in the baghouse hoppers is important to the performance of the instrument. During the outage Covanta found several level probes with the improper orientation. All of the probes have been orientated properly and have been marked externally to facilitate inspection for proper orientation.

Photo 27 - Baghouse 1 -Hopper Level probe – Installed With Incorrect Orientation (Gap should be vertical)

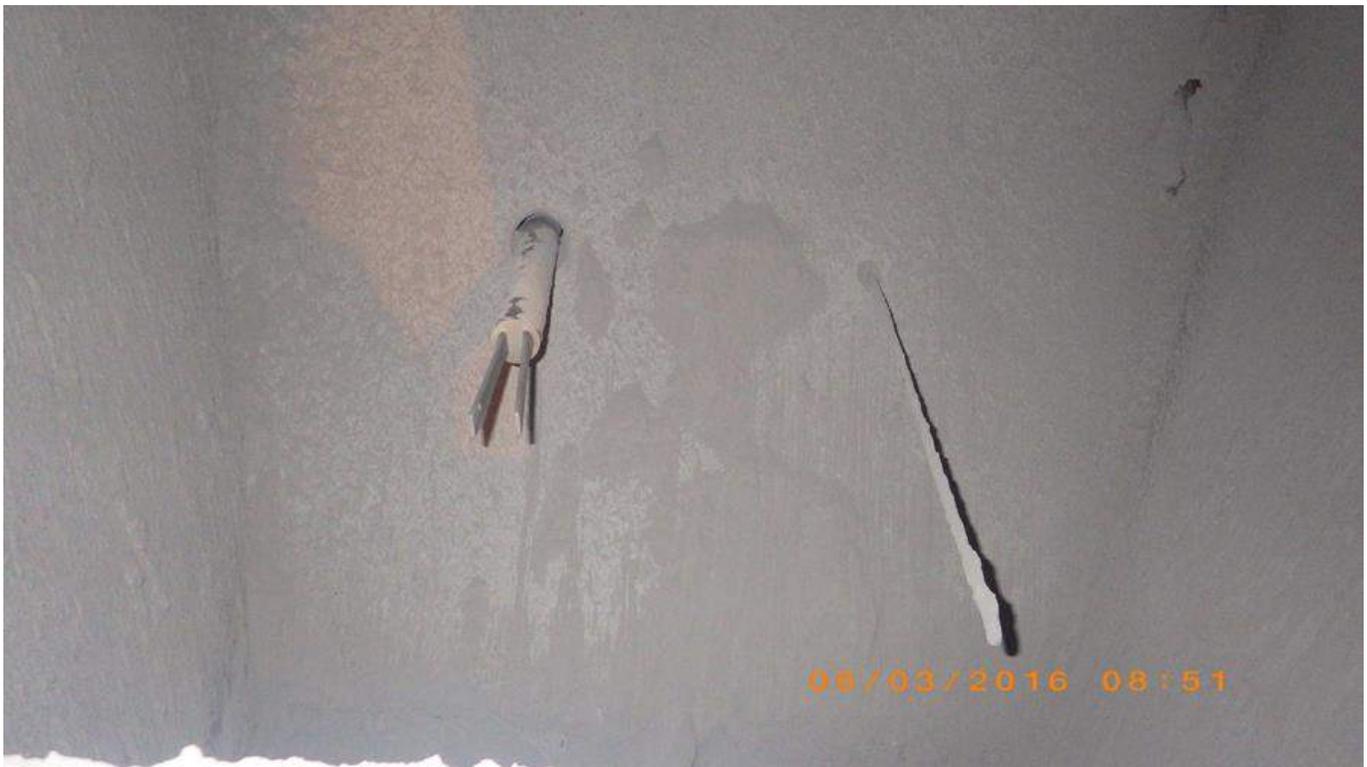
Photo 28 - Baghouse 1 -Hopper Level probe – Installed With Correct Orientation (Gap vertical)

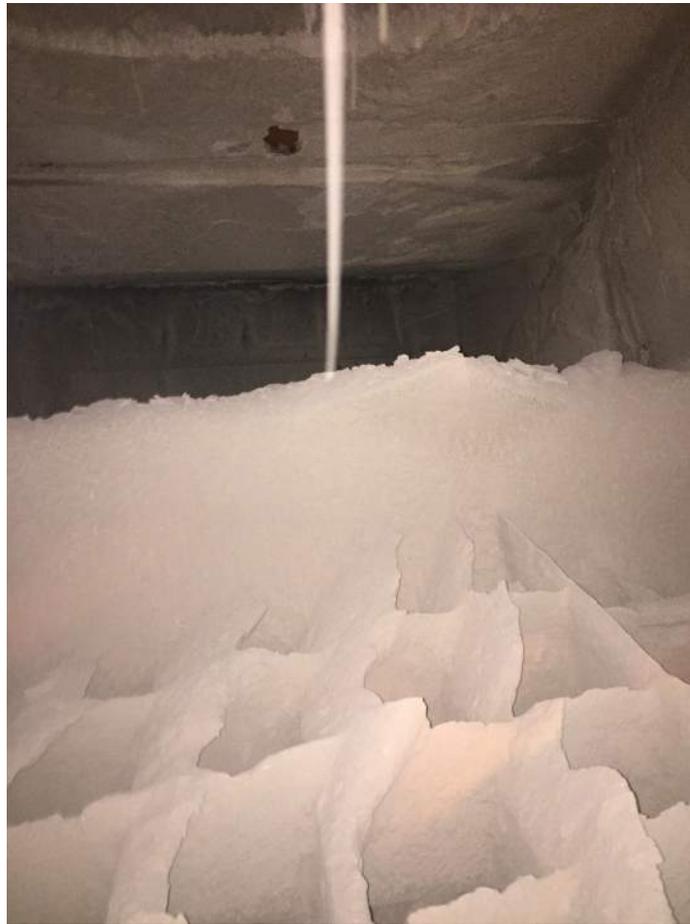
Photo 30 - Vanes at Discharge of Quench Reactor – some Buildup – Not Considered Excessive

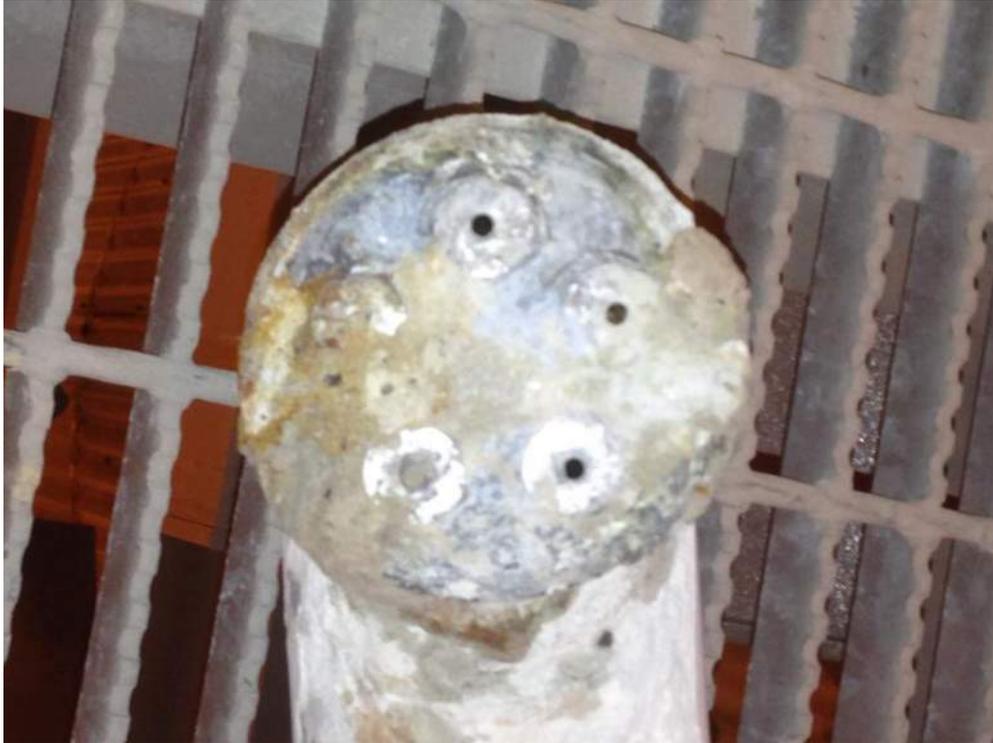
Photo 31 - Spray Nozzle – 3 of 5 Nozzles Plugged – PM Program Lacking

| TASK | NOTES | HDR NOTES | |
|--|--|--|---|
| 58 | Remove Quench tower spray lance; inspect and clean nozzles | 2 of 5 nozzles found plugged; swapped with spare spray lance assembly; complete | Need to implement better PM program on nozzles |

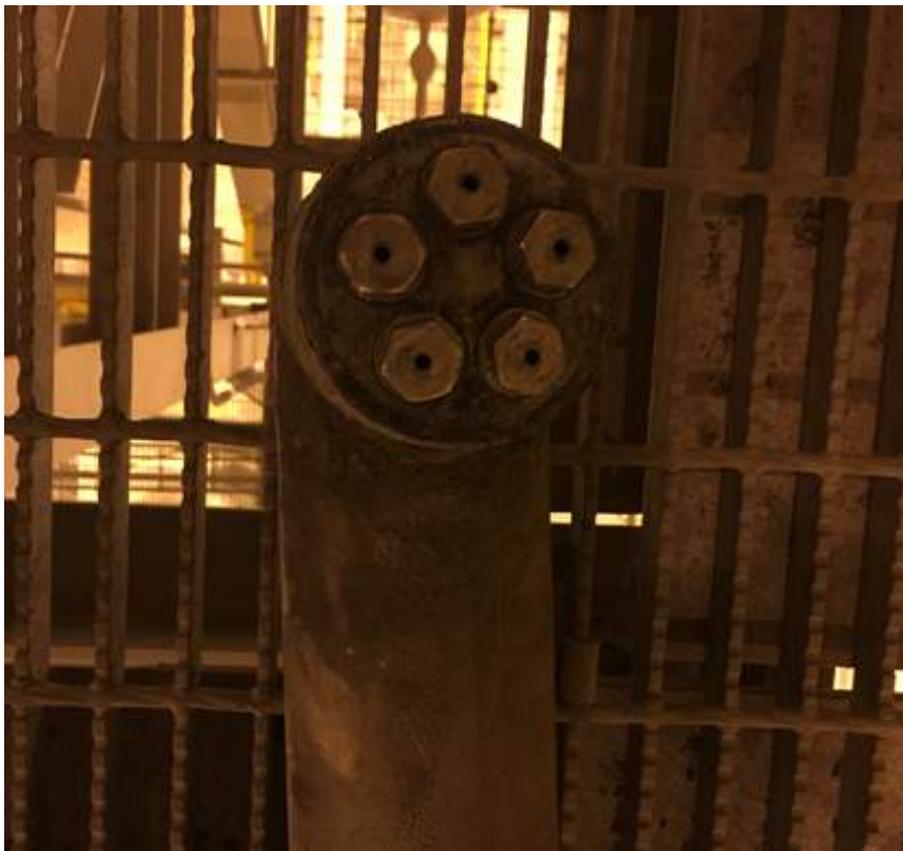
Photo 32 - Spray Nozzle – New Condition

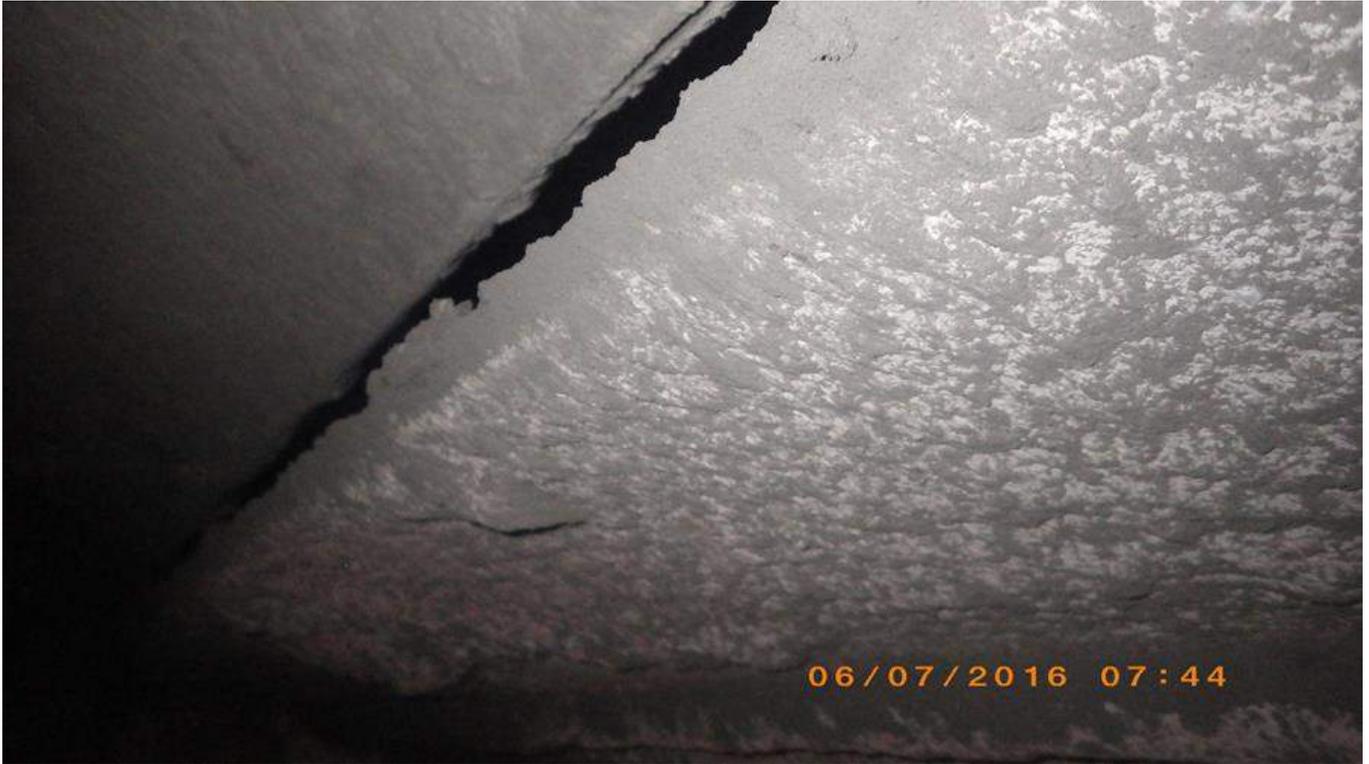
Photo 33 - Damper between Quench and Dry Reactor. Only Slightly Open – Forces air down into Conditioning Rotor

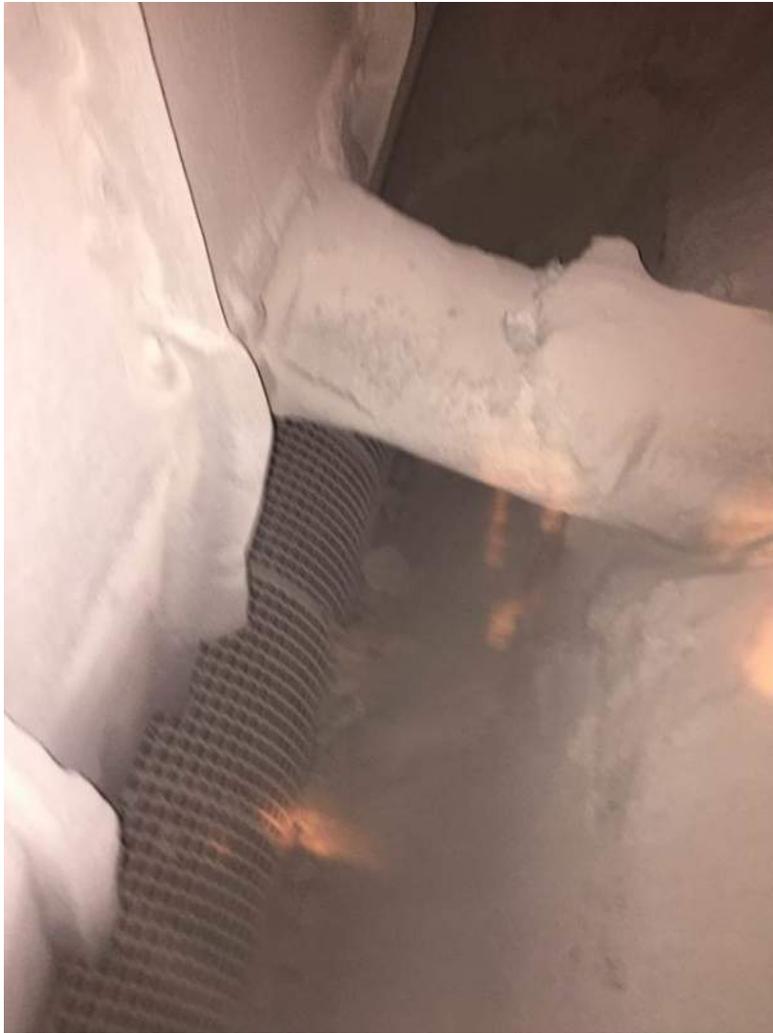
Photo 34 – Lime Screw Feeder (center)– Plugged (as found)

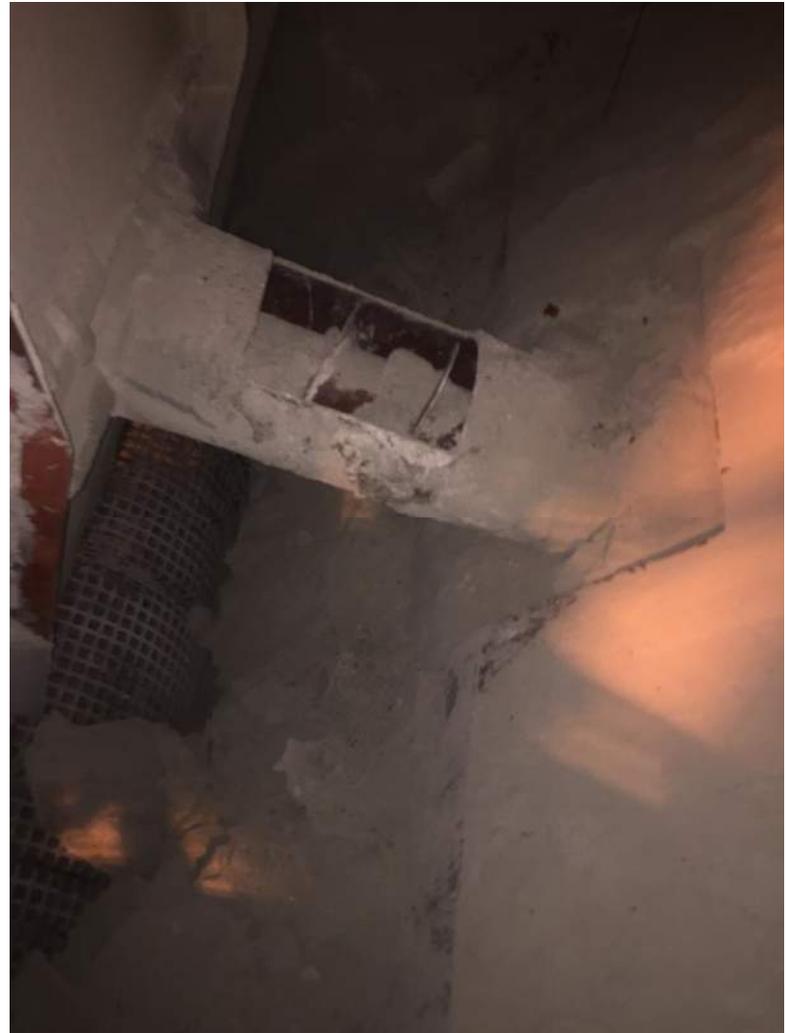
Photo 35 Lime Screw Feeder (center)–Cleared (as left)

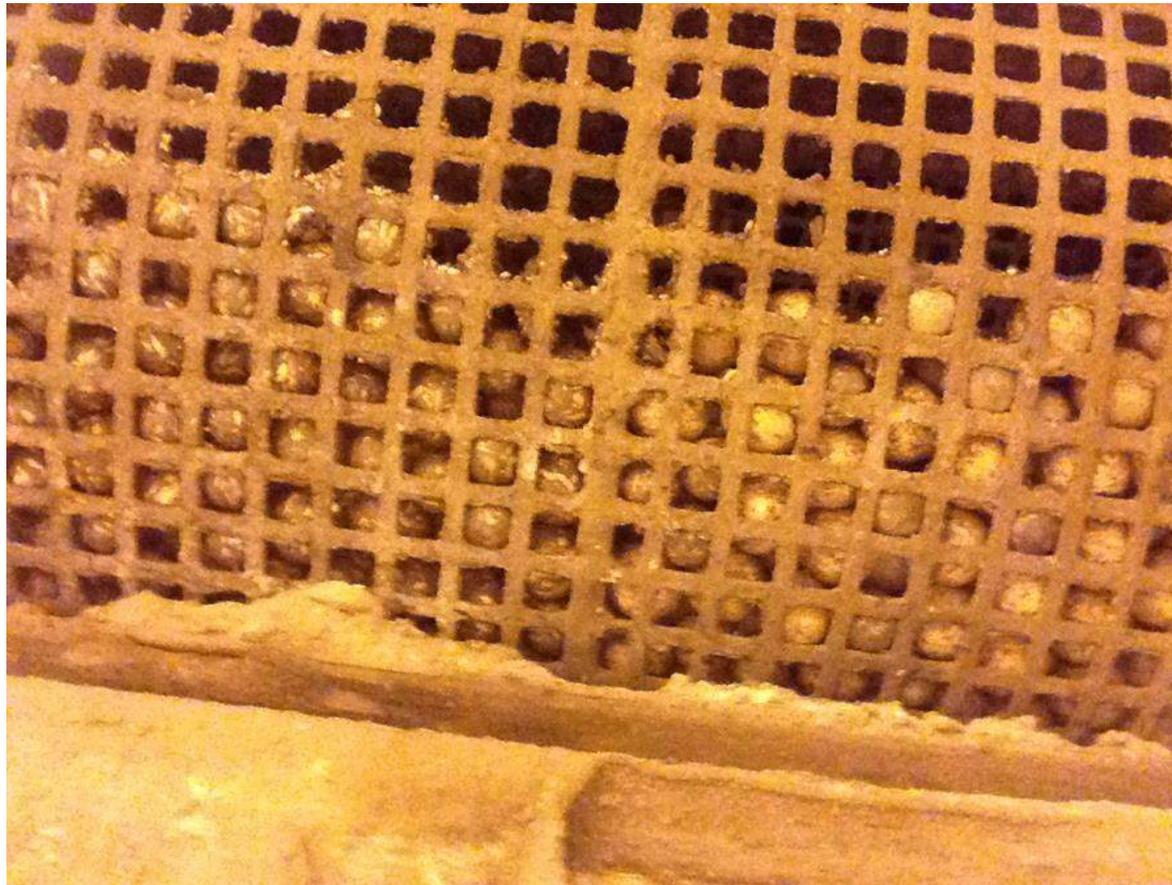
Photo 36 - Conditioning Mixer Clear – (As left)

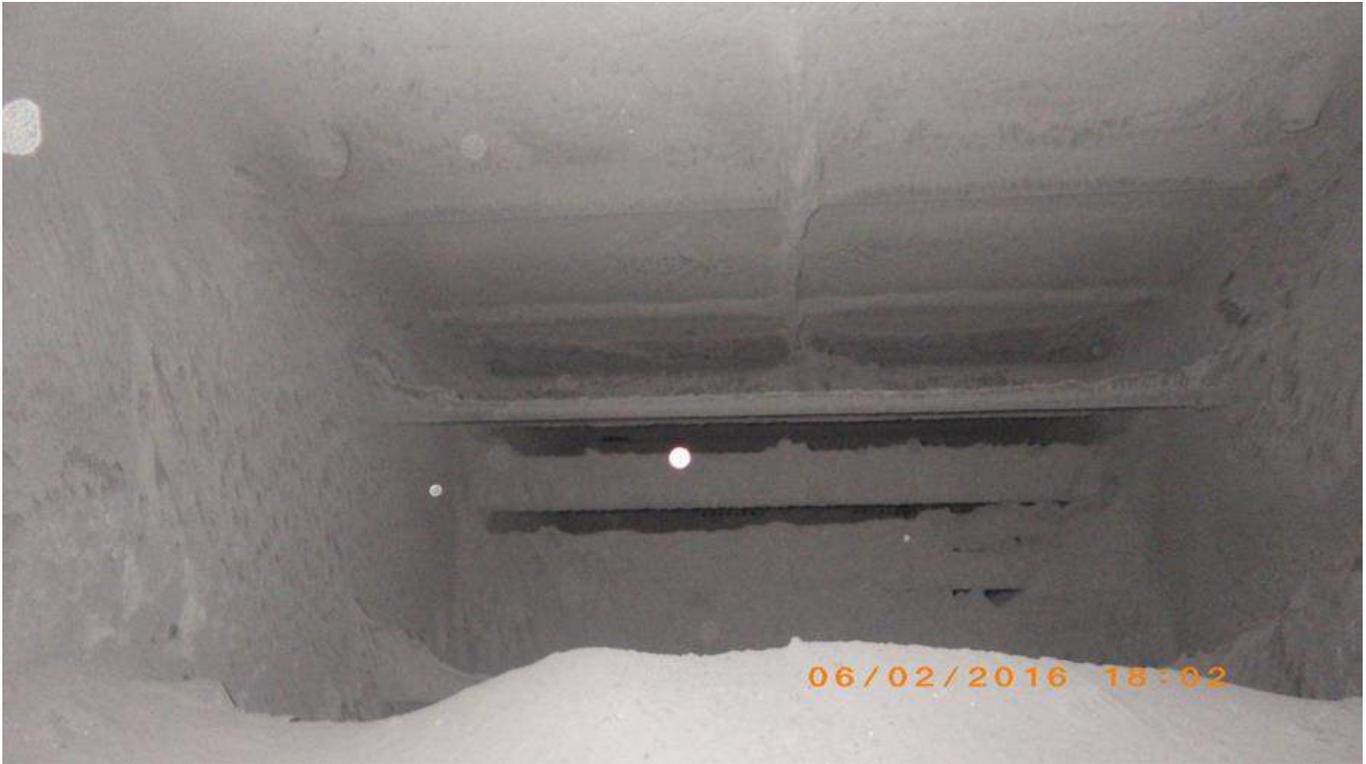
- b. Inspection of the on-line boiler #2 revealed some similar baghouse bag plugging, but to a significantly lesser degree. (See Photo 45 in Attachment 3)
- c. The dispersion plates (screened plates) in the inlet duct to the baghouse had become heavily fouled and plugged, altering the distribution of flue gas and flyash concentrations to the various baghouse compartments. (See Photos 37, 38 and 39 in Attachment 3)

- The inlet duct to the baghouse had heavy deposits of fly ash on the distribution baffle plates. These were cleaned off with the exception of the extreme left and right sides of the second row of baffles (see Photos 37, 38, and 39 in Attachment 3). An uneven distribution of particulate and PAC to the six (6) baghouse compartments could adversely impact the baghouse removal efficiency.

Photo 37 - Inlet To Baghouse Inlet Duct – Baffle Screens at Far End Plugged (as found)

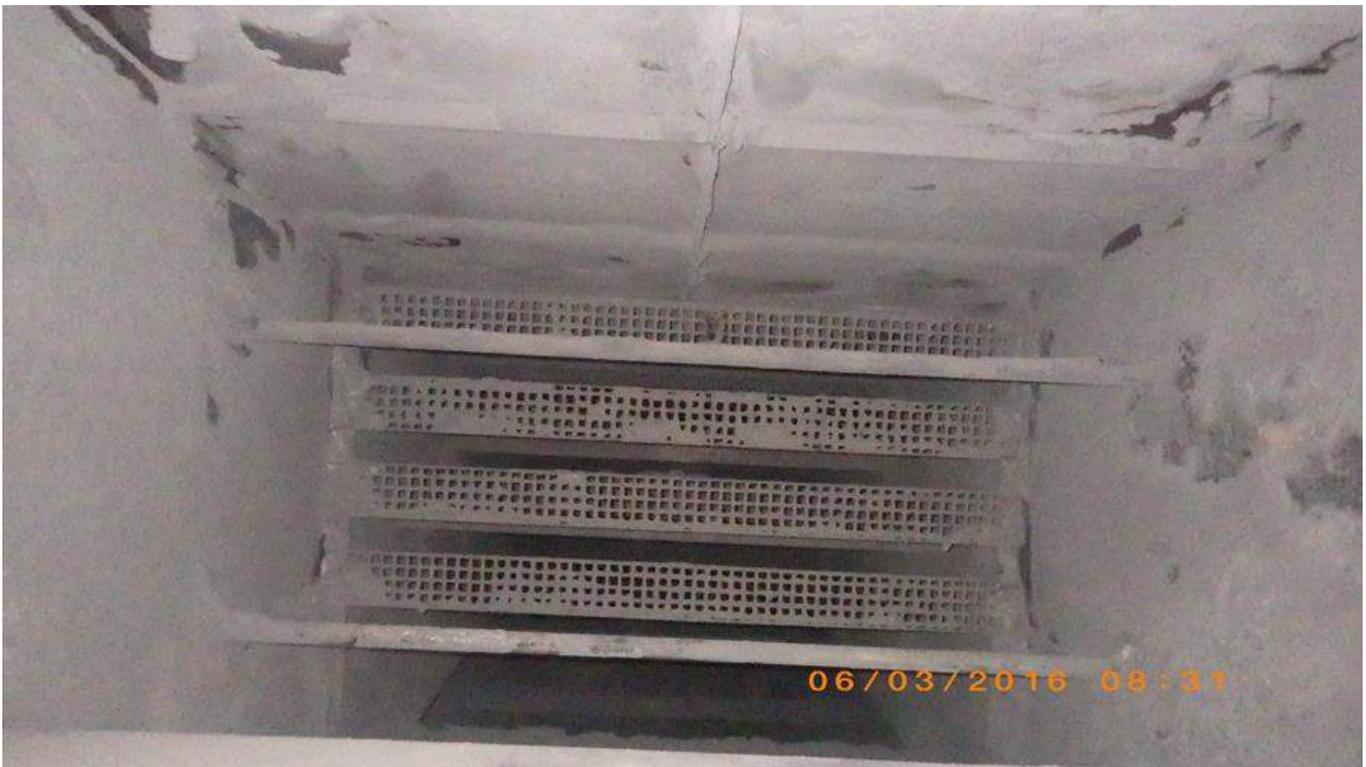
Photo 38 - Inlet To Baghouse Inlet Duct – Baffle Screens at Far End Cleared during Boiler #1 Shutdown (as left)

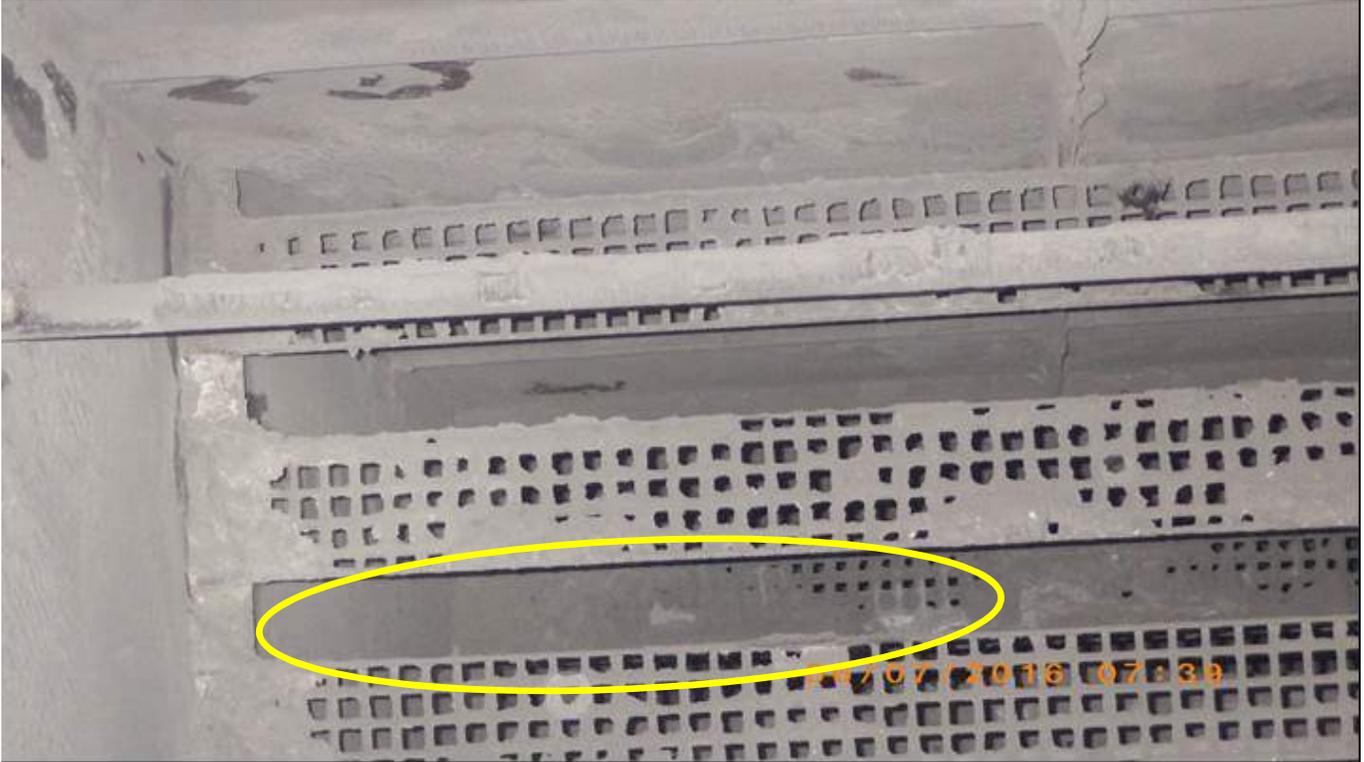
Photo 39 - Close up view of Inlet To Baghouse Inlet Duct – 2nd Row of Baffle Screens Remained Partially Plugged (as left)

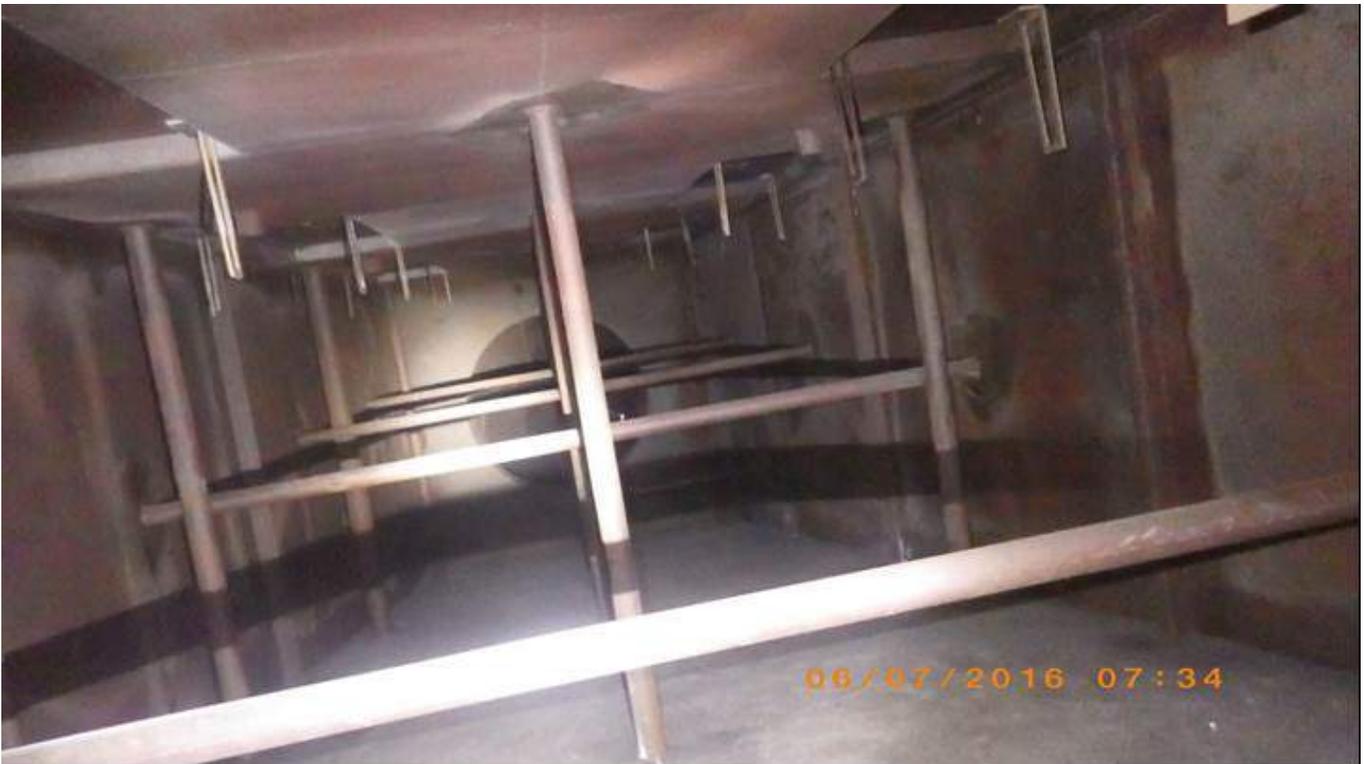
Photo 40 - Baghouse Outlet Duct (Baghouse Clean side)– Appeared Clean

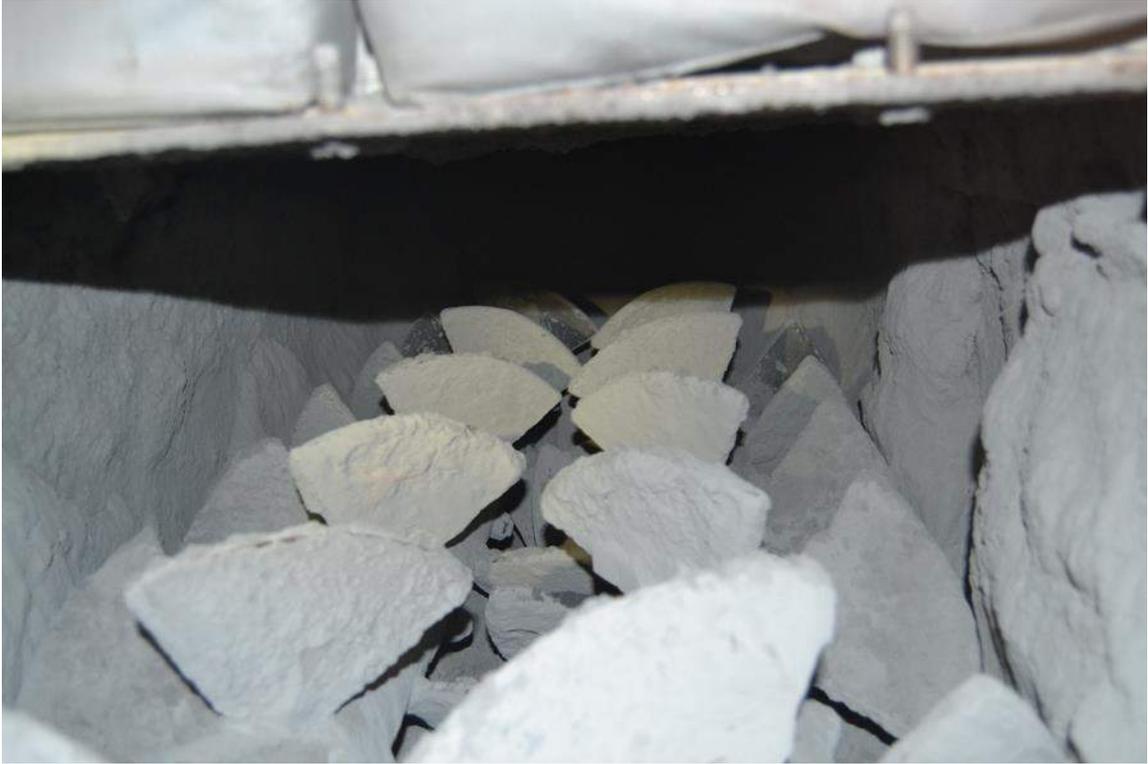
| TASK | NOTES | HDR NOTES | |
|---|---|---|---|
| 66 | Double Shaft Mixers – Inspect water nozzles for damage/pluggage | cleaned; complete | May be some issues with the orientation of the paddles - Covanta completed follow up check on June 11 and confirmed paddle orientation is as designed. |

Photo 41 - Double Shaft Mixers – Some Paddles out of Proper Orientation

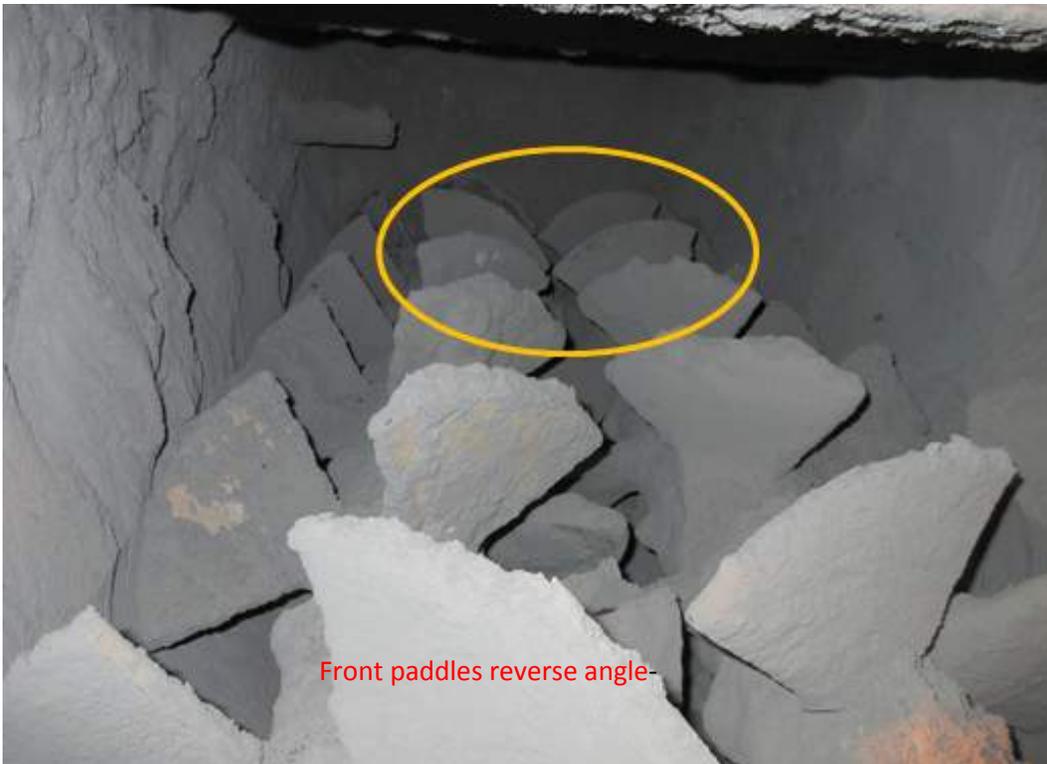
Photo 42 - Double Shaft Mixers – Some Paddles out of Proper Orientation
Front Paddles (under rotary) are reversed angled – reported to be by design

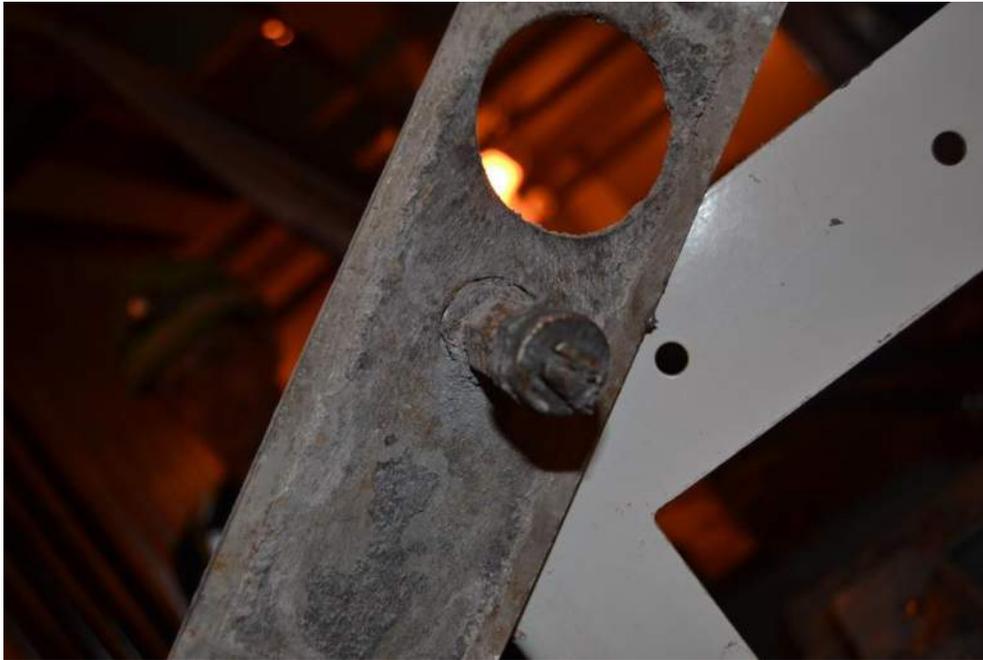
Photo 43 - Double Shaft Mixer for Flyash Recirculation – Spray Nozzles –

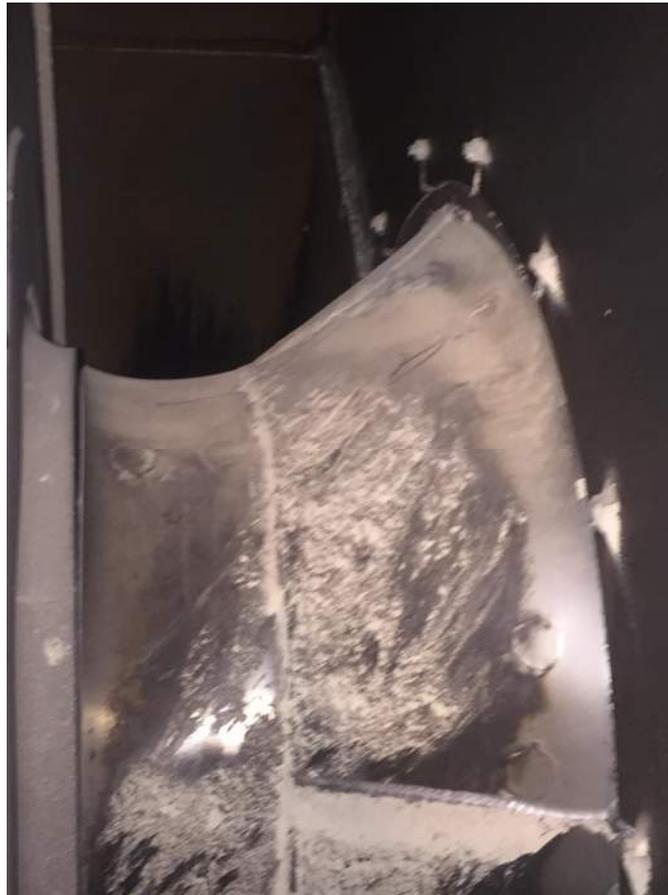
Photo 44 - IGR Fan Inspected – Some Holes in Housing – Refractory lined Inlet Holding up Well

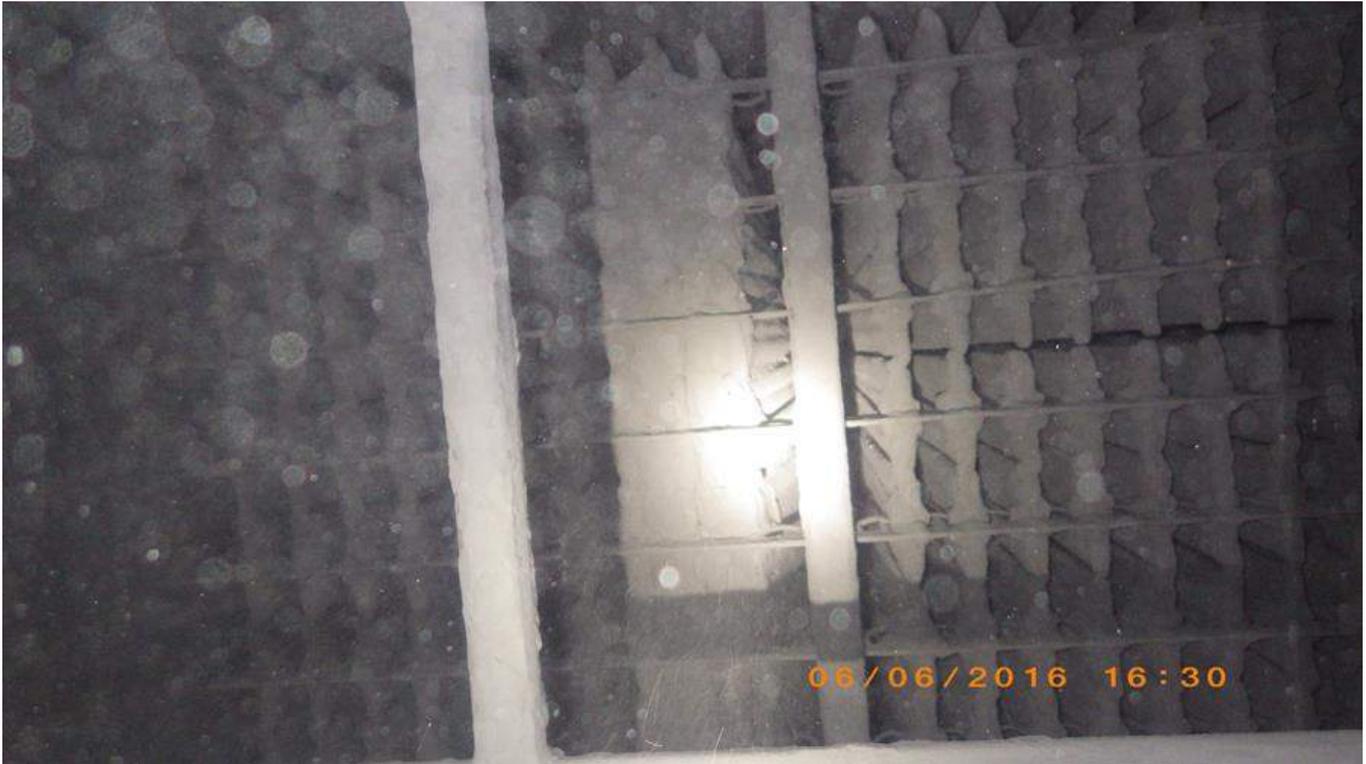
Photo 45 - One Set of Bags in Boiler 2 Cell 2 were Plugged – All Others Clear (Better than Unit 1)
