APPENDIX C

Site Photographic Record

Site Photographic Record (Selected Photos) - Durham-York Energy Centre Surface Water Monitoring Program - During Construction Year 1

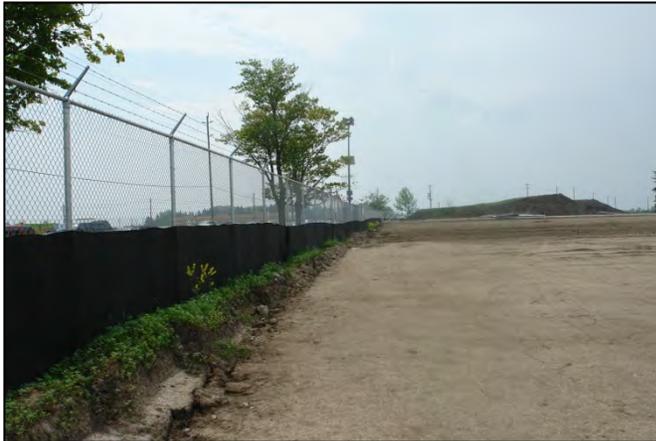
Photograph 1: View Site Fence at Gate 1 (Eastern Side of Site) Looking South on May 29, 2012

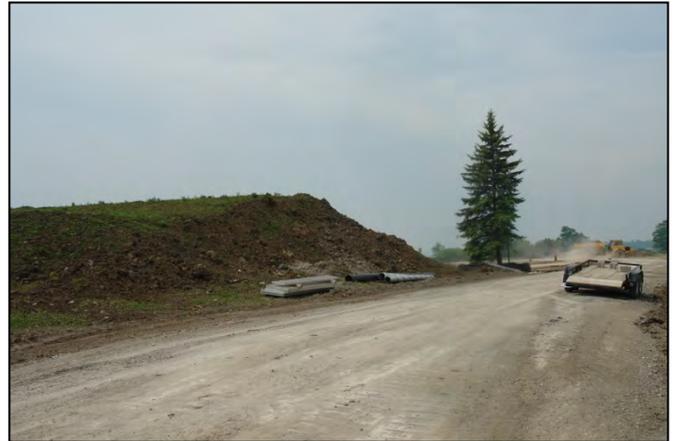
Photograph 2: View of the 'Stock Pile - Working' looking East on May 29, 2012

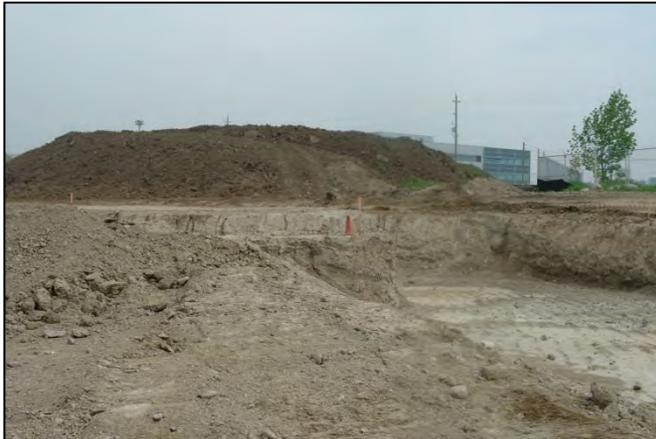
Photograph 3: View looking northeast towards future East SWM Pond inlet on May 29, 2012

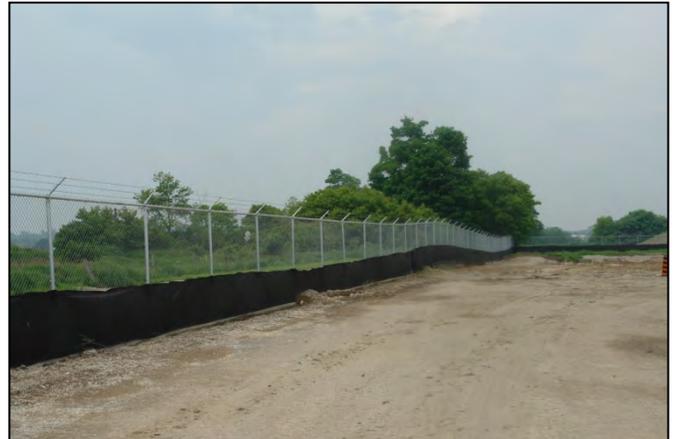
Photograph 4: View looking west towards future East SWM Pond outlet on May 29, 2012

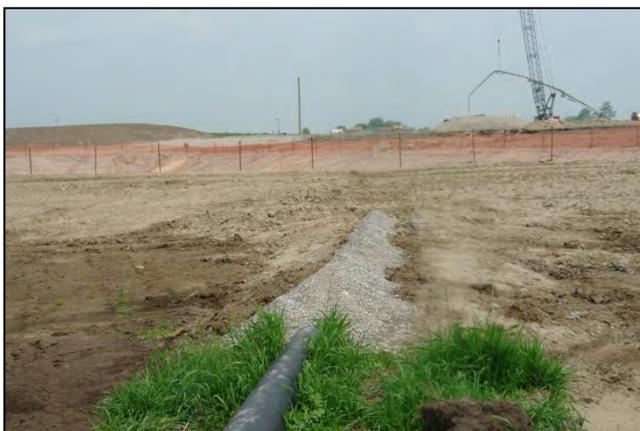
Photograph 5: View looking north towards temporary West SWM Pond outlet on May 29, 2012

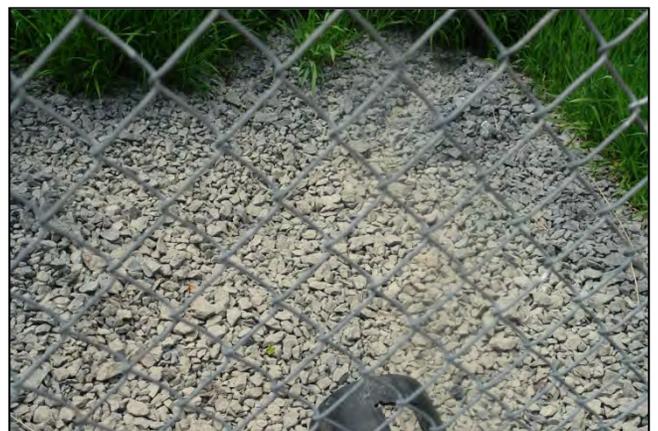
Photograph 6: Closer View looking south towards temporary West SWM Pond outlet on May 29, 2012

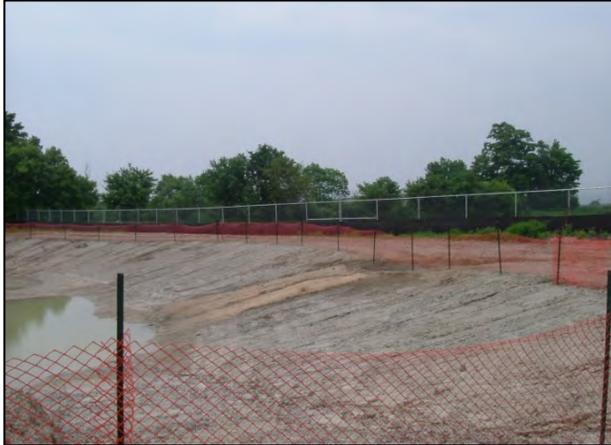
Photograph 7: View looking southwest towards temporary West SWM Pond inlet on May 29, 2012

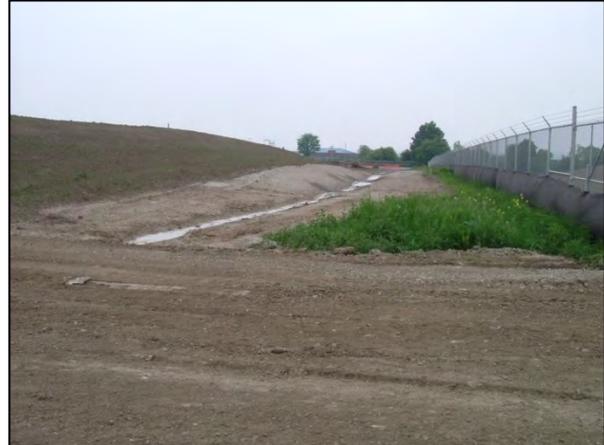
Photograph 8: View looking south capturing Stock Pile #1, western perimeter swale and silt fence on May 29, 2012

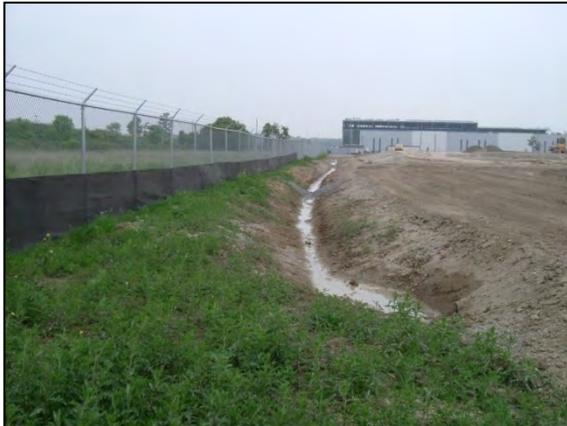
Photograph 9: View looking east capturing northern perimeter swale and silt fence on May 29, 2012

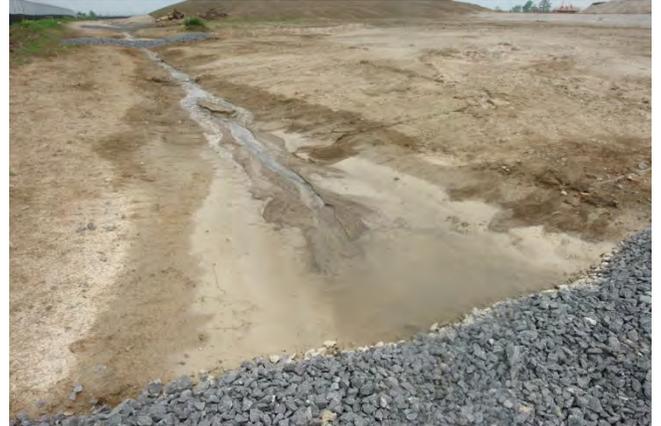
Photograph 10: Closer view of sediment build-up at upstream end of furthest downstream rock-check dam on May 29, 2012

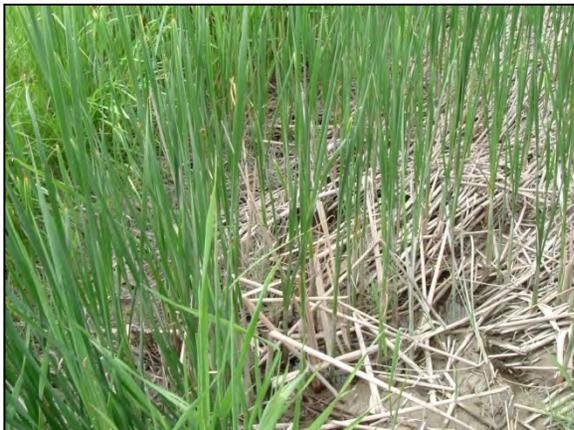
Photograph 11: View of Receiving Swale SW conditions in close proximity to SW-1 station on May 29, 2012

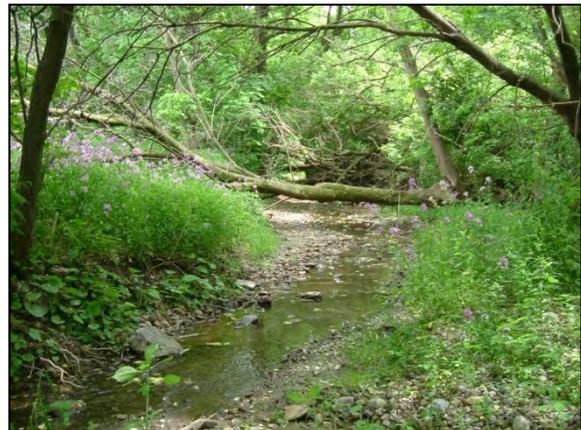
Photograph 12: View of Tooley Creek looking & from downstream end of Hwy 401 box culvert on May 29, 2012

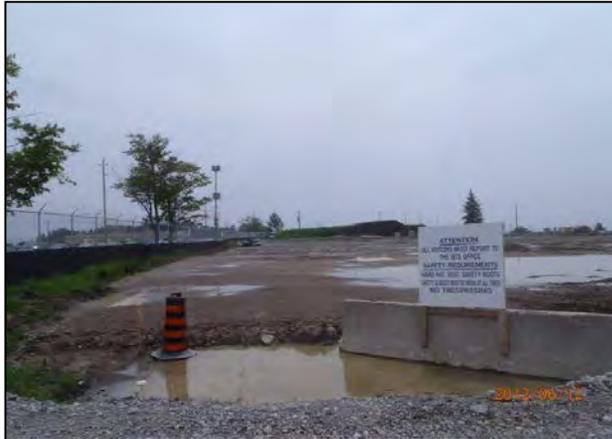
Photograph 13: View Site Fence at Gate 1 (Eastern Side of Site) Looking South on June 12, 2012

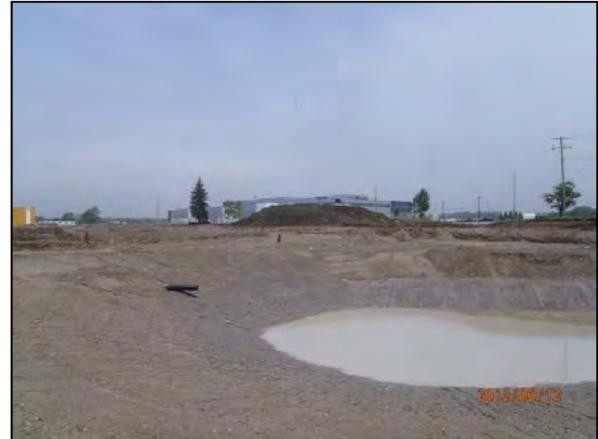
Photograph 14: View of East SWM Pond (incl temp PVC outlet pipe), the 'Stock Pile - Working' looking Northeast on June 12, 2012

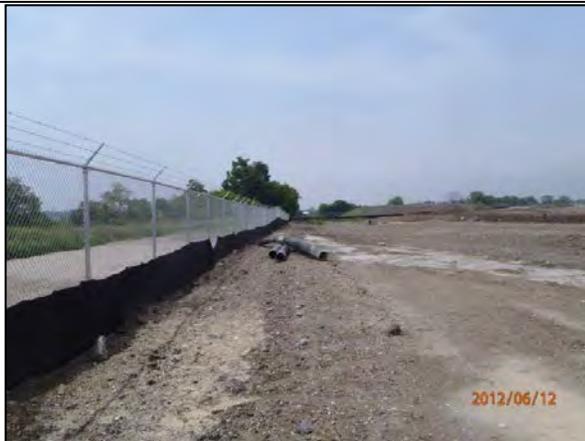
Photograph 15: View looking west along southern Site perimeter June 12, 2012

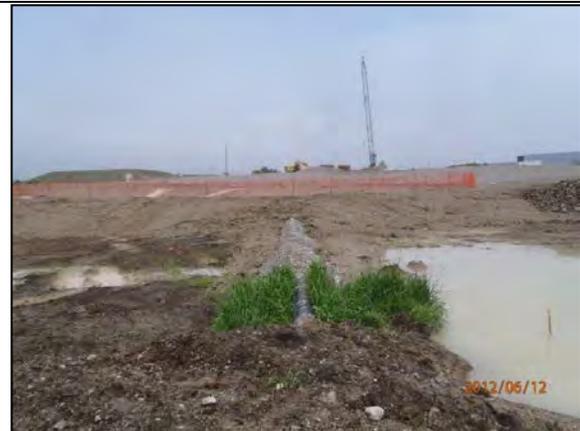
Photograph 16: View looking west along southern Site perimeter June 12, 2012

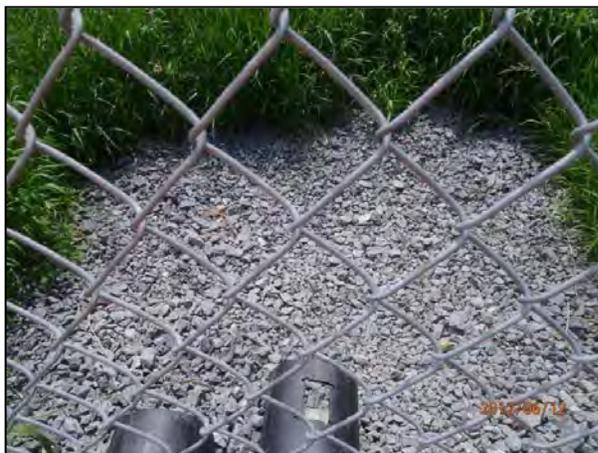
Photograph 17: Closer View looking south at temporary East & West SWM Pond outlets on June 12, 2012

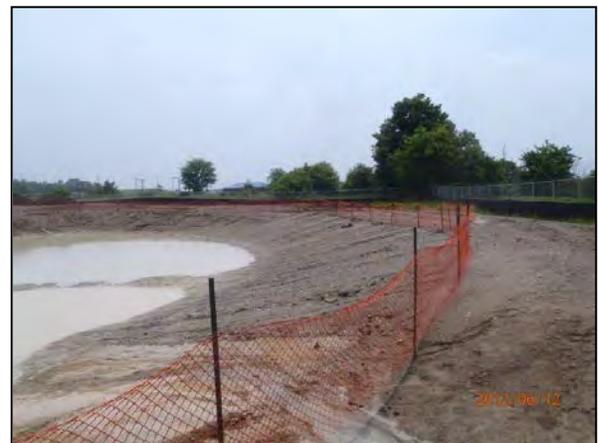
Photograph 18: View looking southwest towards temporary West SWM Pond inlet on June 12, 2012

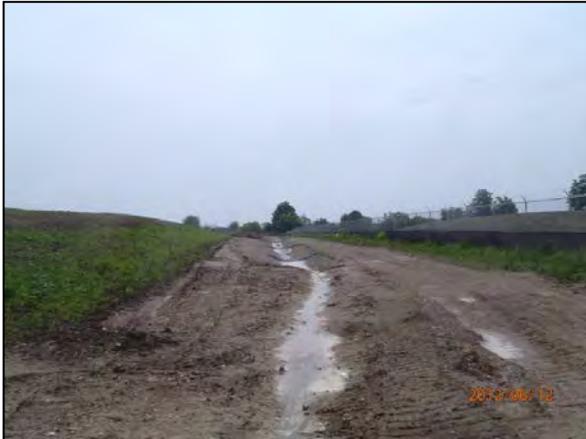
Photograph 19: View looking south capturing Stock Pile #1, western perimeter swale and silt fence on June 12, 2012

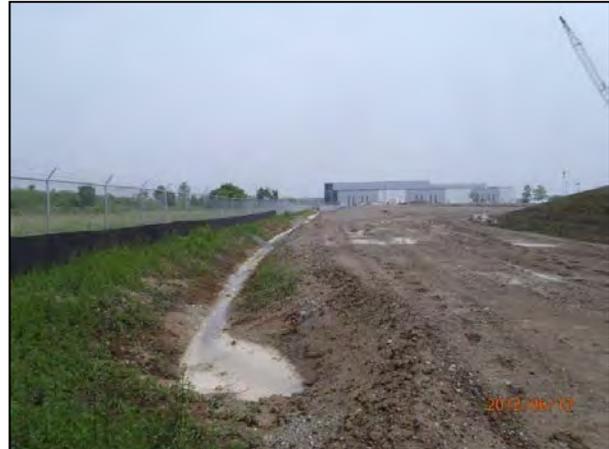
Photograph 20: View looking east capturing northern perimeter swale and silt fence on June 12, 2012

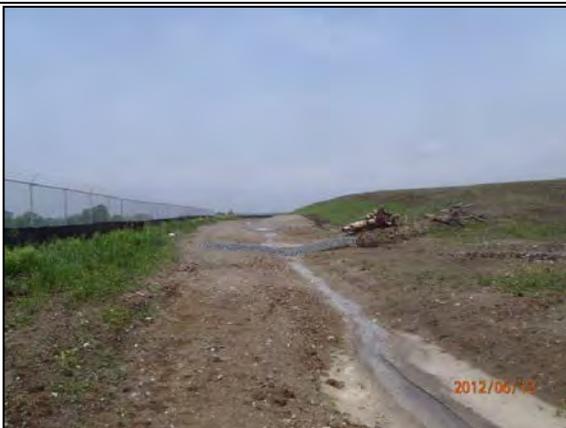
Photograph 21: View looking north and upstream along western interceptor swale on June 12, 2012

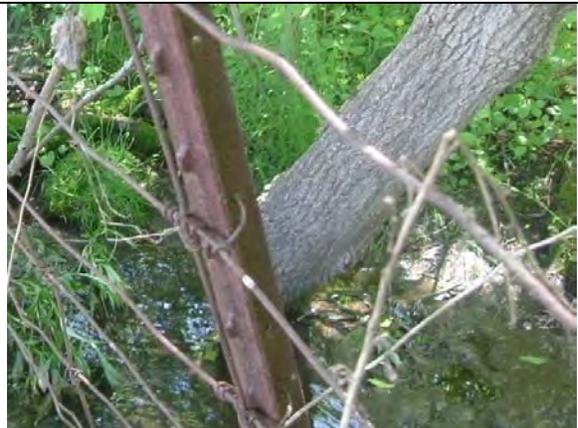
Photograph 22: View of surface water sampling of receiving swale from outside of fence-line on June 5, 2012

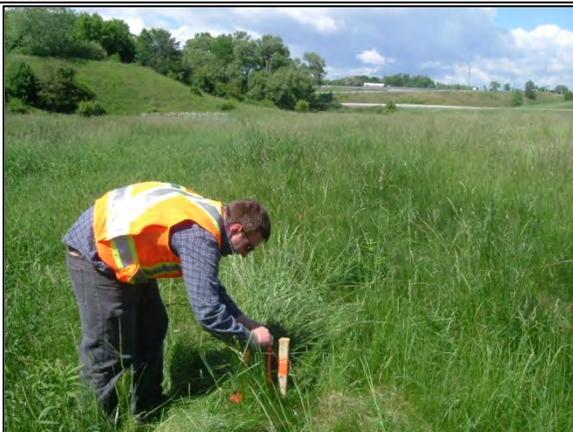
Photograph 23: View looking north of Upstream SW3 Station on Tooley Creek on June 5, 2012

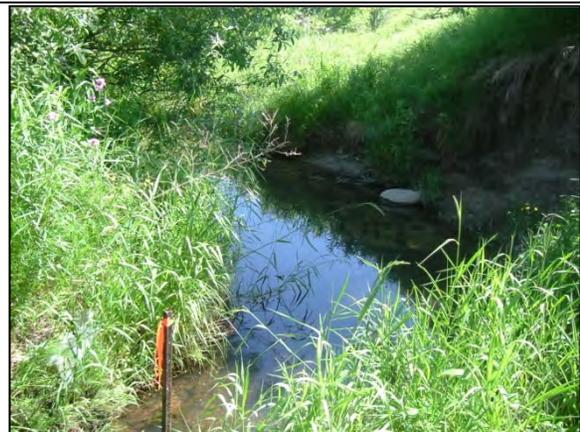
Photograph 24: View looking south at Downstream SW4 Station on Tooley Creek on June 5, 2012

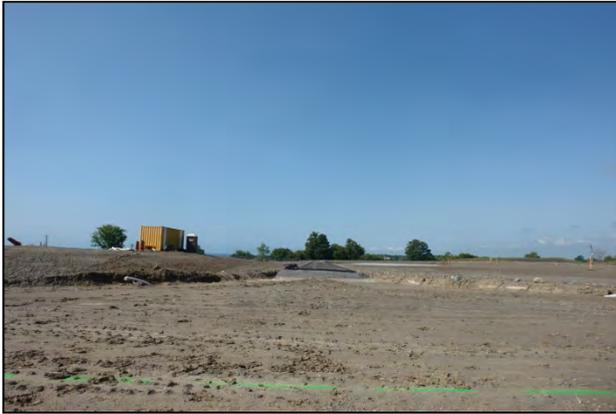
Photograph 25: View looking west of Paved roadway under construction on September 5, 2012

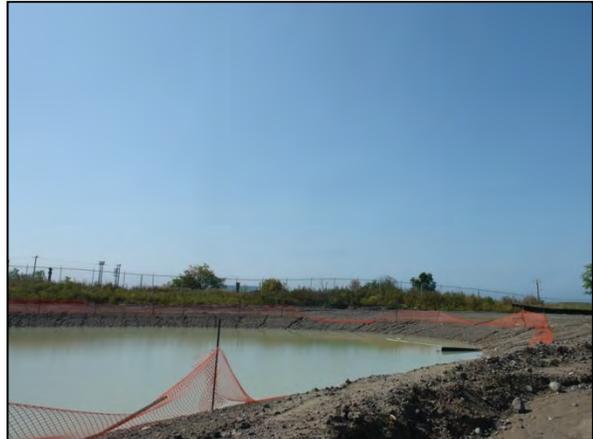
Photograph 26: South View of East SWM Pond (incl temp PVC outlet pipe partially submerged), on September 5, 2012

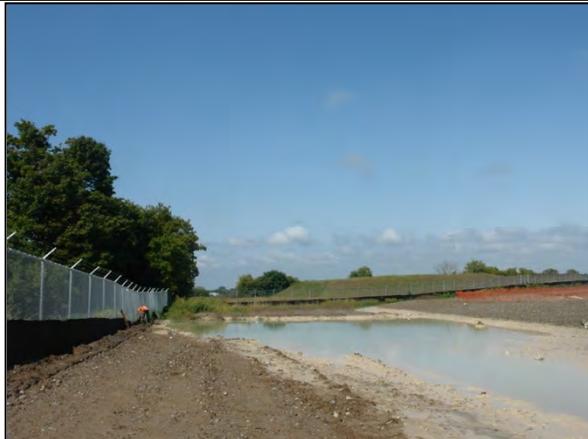
Photograph 27: View looking west along southern Site perimeter September 5, 2012

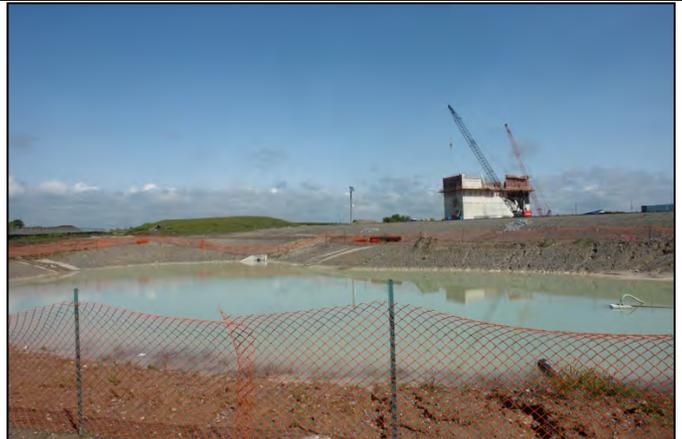
Photograph 28: View looking northwest of West SWM Pond, including float pump, on September 5, 2012

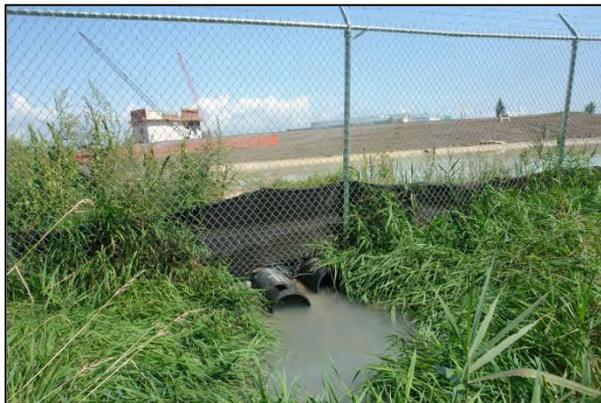
Photograph 29: View looking north at temporary East & West SWM Pond outfall location on Sept 5, 2012

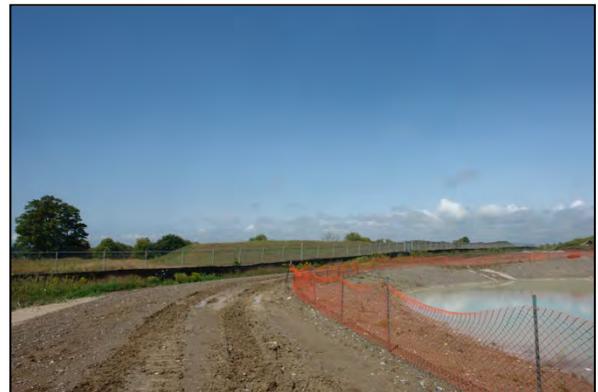
Photograph 30: View looking west towards temporary West SWM Pond inlet and western perimeter fence on Sept 5, 2012

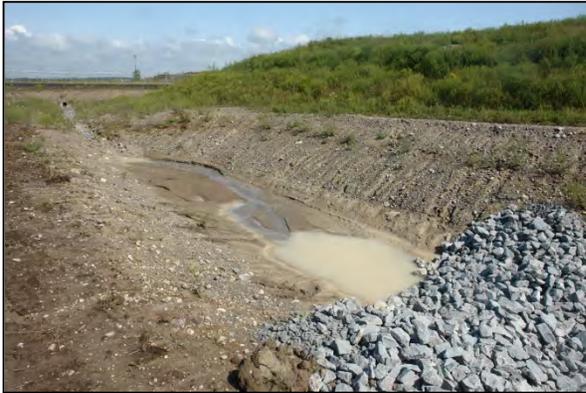
Photograph 31: View looking north at rock check dam within western interceptor swale, along with well vegetated Stock Pile #1 on September 5, 2012

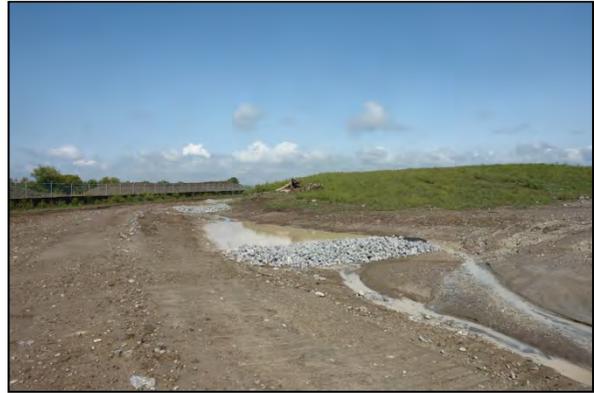
Photograph 32: View looking north and upstream along western interceptor swale and rock check dam in need of repair on September 5, 2012

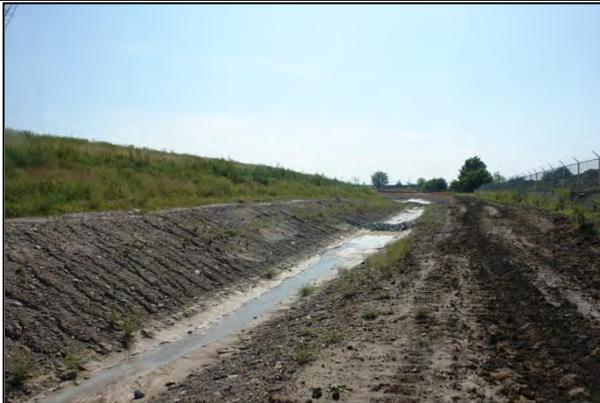
Photograph 33: View looking south capturing western perimeter silt fence and interceptor swale on September 5, 2012

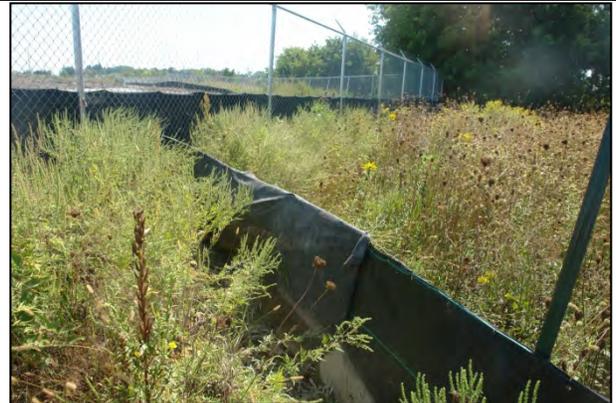
Photograph 34: View looking east at southwest corner (off-Site), along southern perimeter fence on Region of Durham land on September 5, 2012

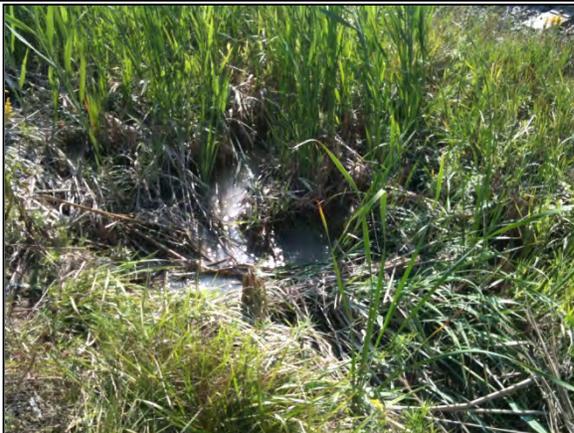
Photograph 35: View of receiving swale conditions at Upstream SW-1 Station on September 6, 2012

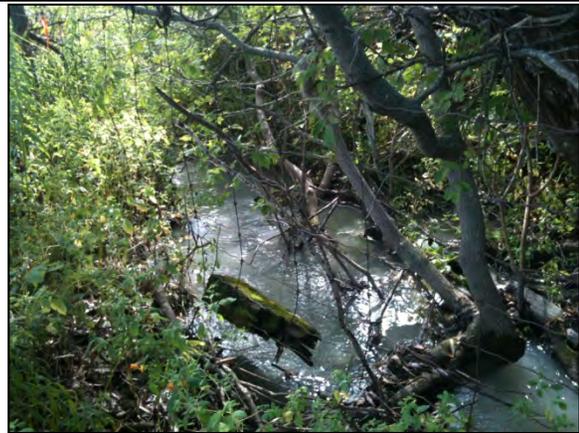
Photograph 36: View of receiving swale conditions at Downstream SW-2 Station on September 6, 2012

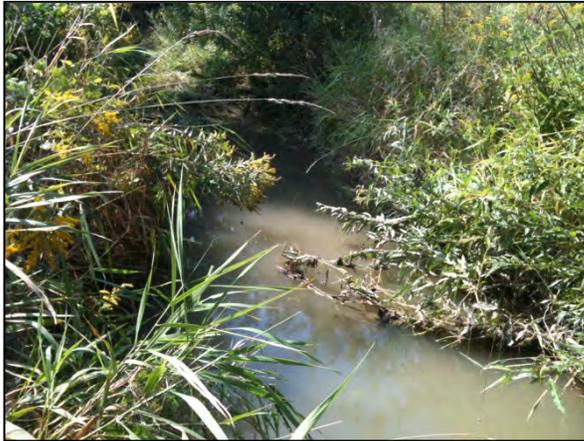
Photograph 37: View of receiving swale conditions at Downstream SW-4 Station on September 6, 2012

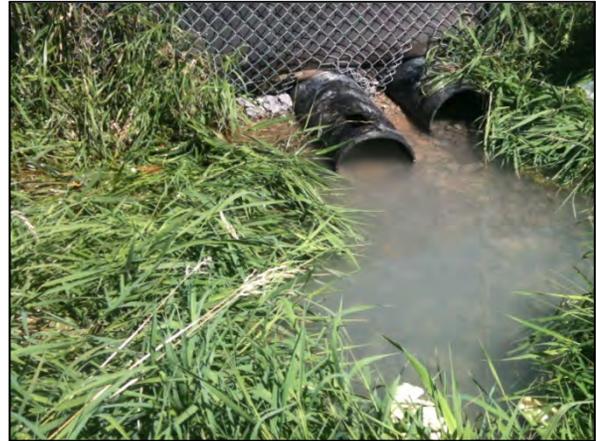
Photograph 38: Closer View looking north at temporary East & West SWM Pond outfall location on Sept 6, 2012

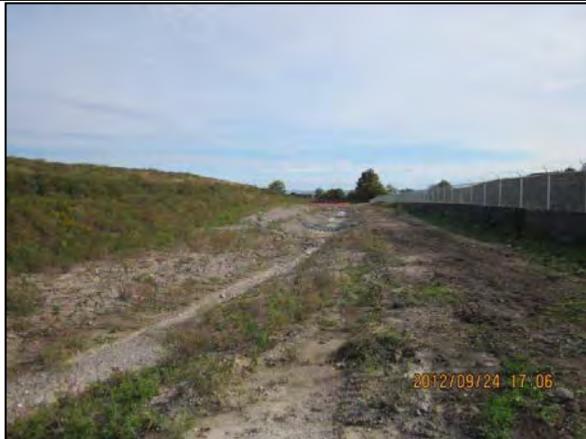
Photograph 39: View looking south capturing western perimeter silt fence and interceptor swale on September 24, 2012

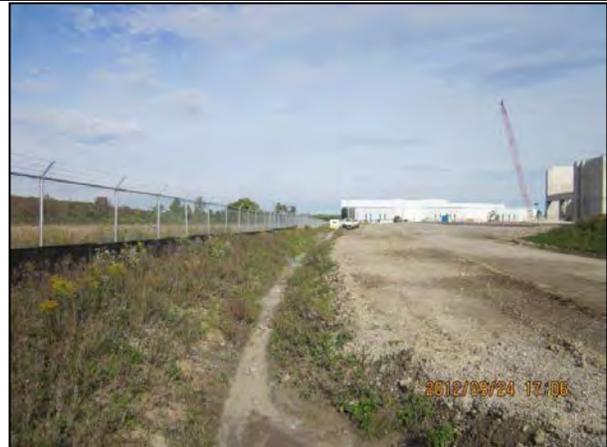
Photograph 40: View looking east capturing northern perimeter swale and silt fence on September 24, 2012

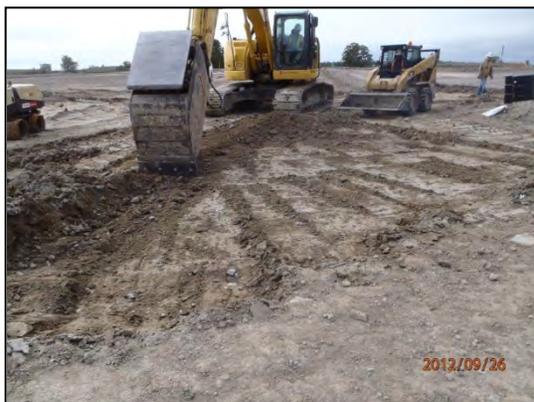
Photograph 41: View of Site surface where crane hydraulic oil spill occurred on previous day (Sept 25/12) during clean-up and removal efforts on Sept 26, 2012

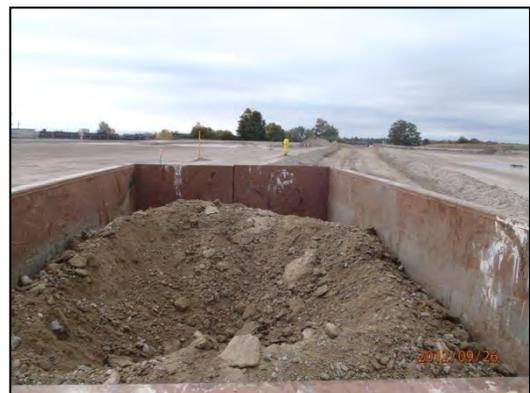
Photograph 42: View of removed soil from crane hydraulic oil spill incident being prepared for transport to Waste disposal yard on September 26 2012

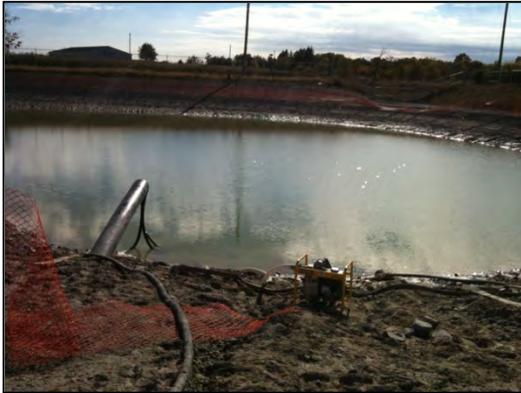
Photograph 43: View of East SWM Pond (incl temp PVC outlet pipe well above water level, with no controlled discharge), during sampling visit on September 28, 2012

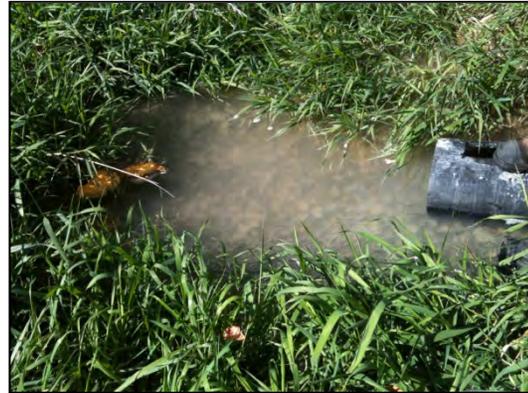
Photograph 44: View of SWM Pond outfall conditions on September 28, 2012

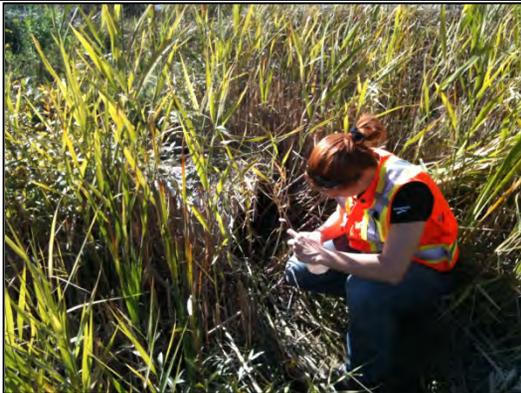
Photograph 45: View of receiving swale conditions at Upstream SW-1 Station on September 28, 2012

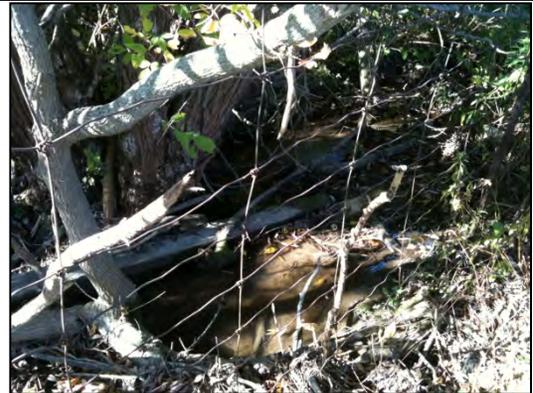
Photograph 46: View of receiving swale conditions at Downstream SW-2 Station on September 28, 2012

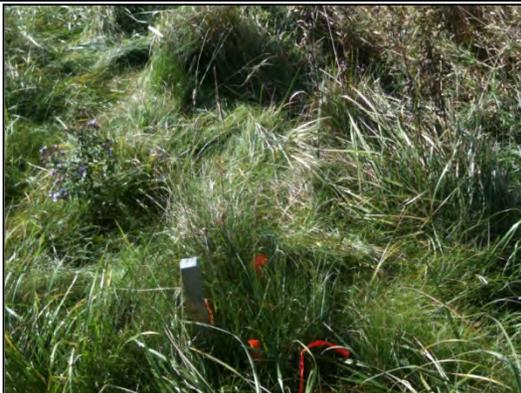
Photograph 47: View looking at Upstream Tooley Creek SW-3 Station on September 28, 2012

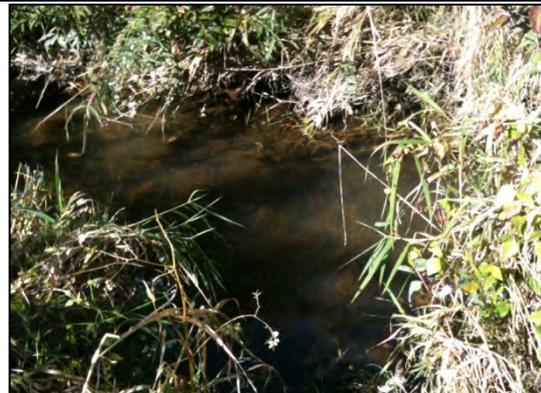
Photograph 48: View looking at Downstream Tooley Creek SW-4 Station on September 28, 2012

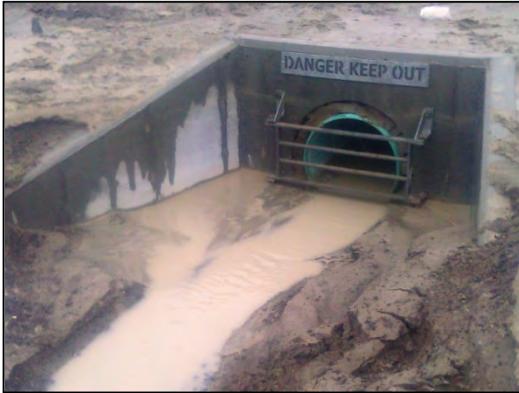
Photograph 49: View of West SWM Pond inlet during Site Visit on November 1, 2012

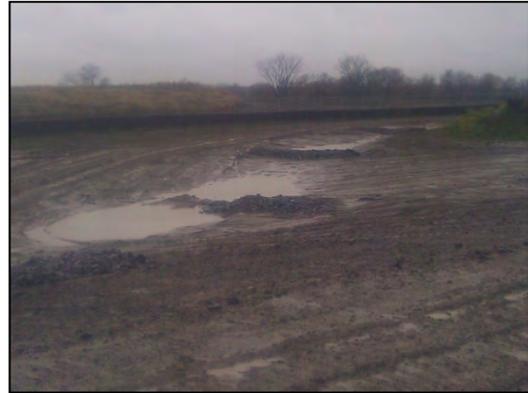
Photograph 50: : View looking north and upstream along western interceptor swale on November 1, 2012

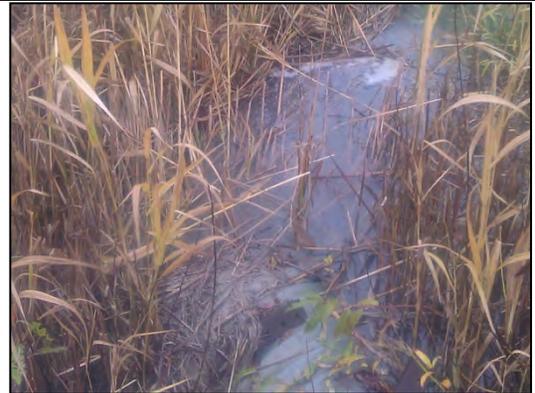
Photograph 52: View of receiving swale conditions at Upstream SW-1 Station on November 1, 2012

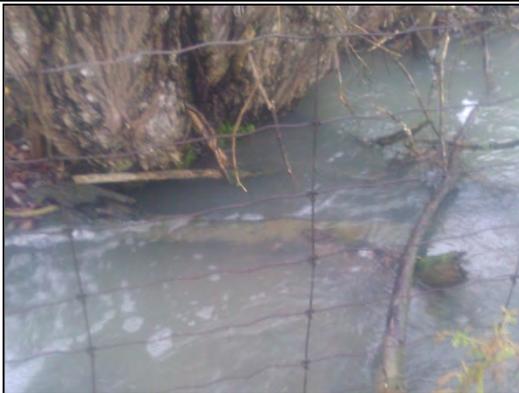
Photograph 53: View of receiving swale conditions at Downstream SW-2 Station on November 1, 2012

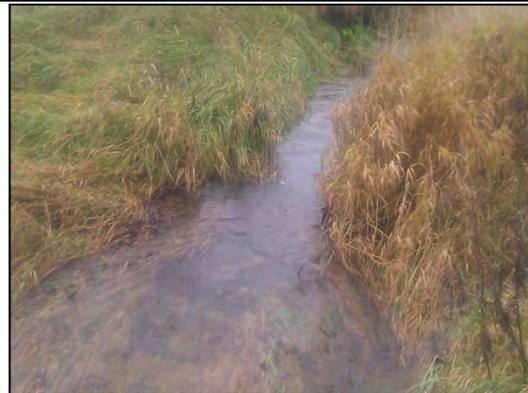
Photograph 54: View looking at Upstream Tooley Creek SW-3 Station on November 1, 2012

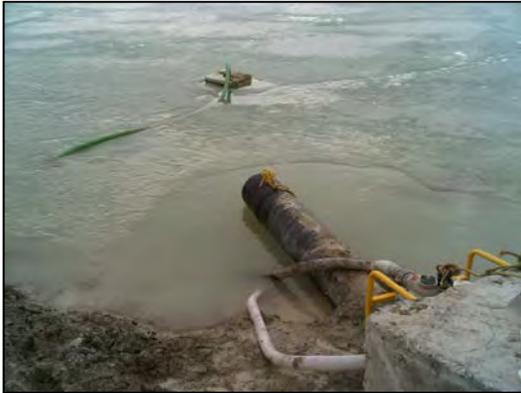
Photograph 55: View of East SWM Pond incl temp PVC outlet pipe, with no controlled discharge, during (pre-spring) freshet conditions on March 12, 2013

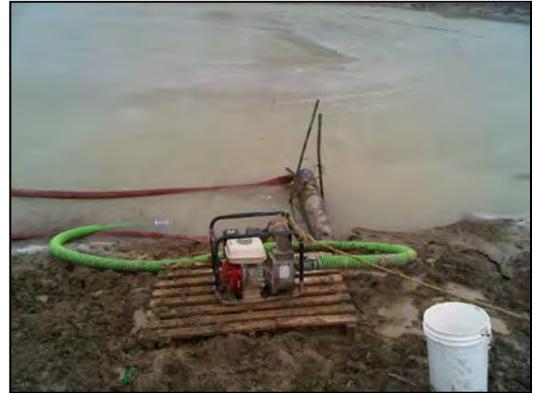
Photograph 56: Closer View of West SWM Pond incl temp PVC outlet pipe, with no controlled discharge, during (pre-spring) freshet conditions on March 12, 2013

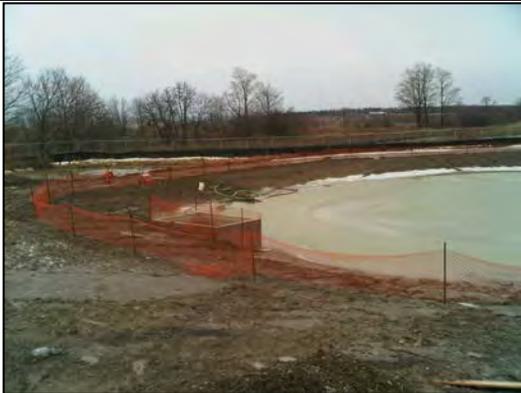
Photograph 57: View of West SWM Pond, towards southwest corner on March 12, 2013

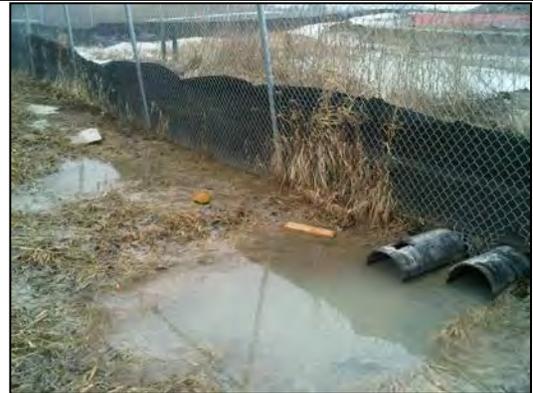
Photograph 58: View of temporary East & West SWM Pond outfall location on March 12, 2013

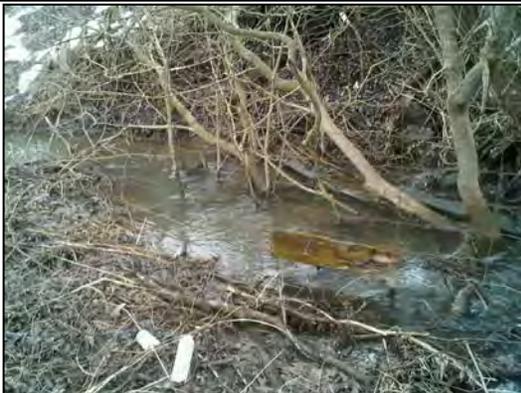
Photograph 59: View of receiving swale conditions at Downstream SW-2 Station on March 12, 2013

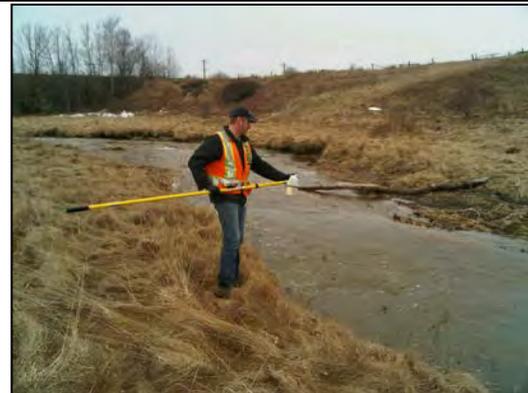
Photograph 60: View looking south at Upstream Tooley Creek SW-3 Station during sampling effort on March 12, 2013

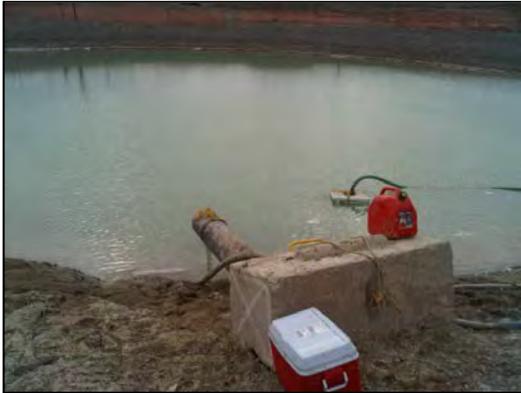
Photograph 61: View of East SWM Pond incl temp PVC outlet pipe, during a controlled discharge on April 8, 2013

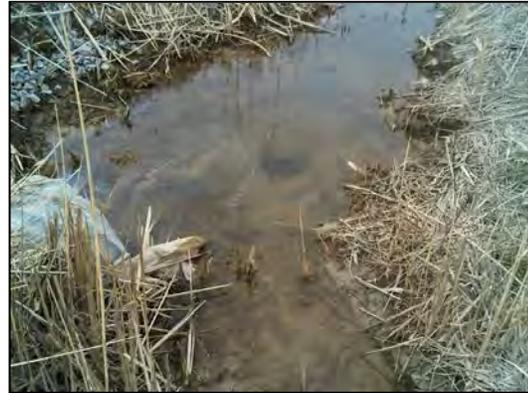
Photograph 62: View of receiving swale conditions at Upstream SW-1 Station on April 8, 2013

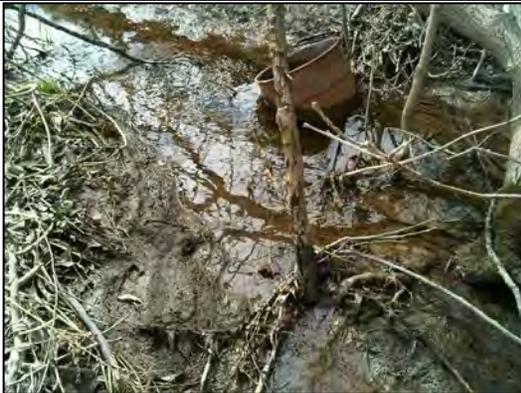
Photograph 63: View of receiving swale conditions at Downstream SW-2 Station on April 8, 2013

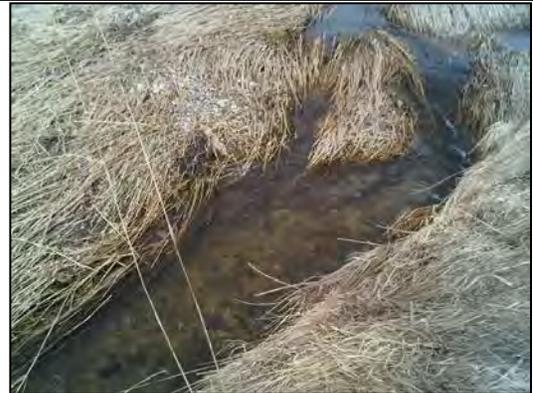
Photograph 64: Closer View at Upstream Tooley Creek SW-3 Station during sampling effort on April 8, 2013

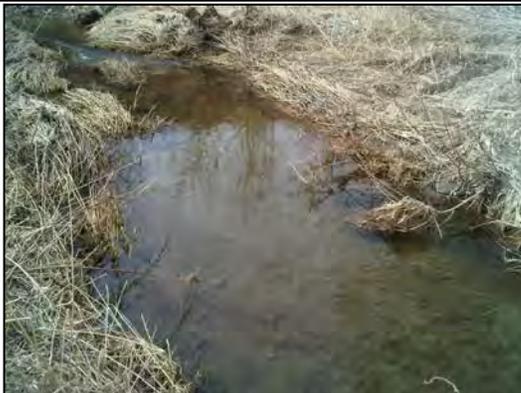
Photograph 65: View looking at Downstream Tooley Creek SW-4 Station on April 8, 2013

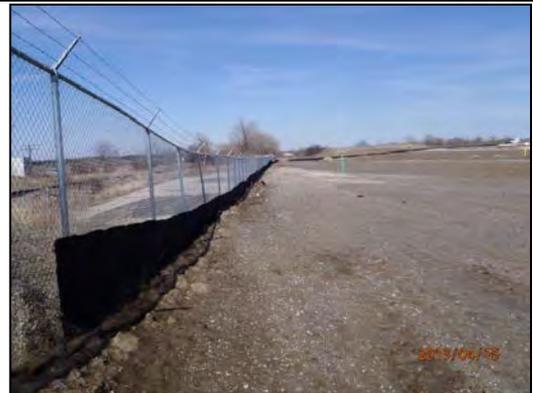
Photograph 66: View of southern perimeter silt fence on April 15, 2013

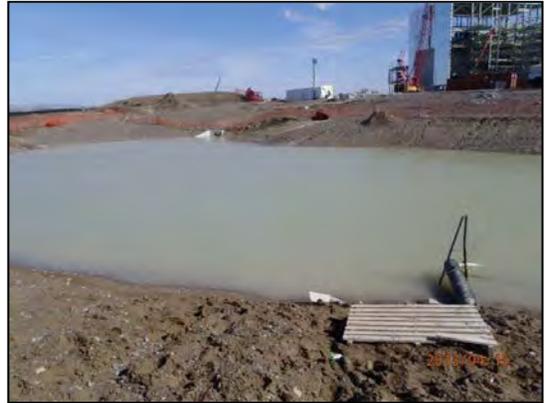
Photograph 68: View of West SWM Pond incl temp PVC outlet pipe on April 15, 2013

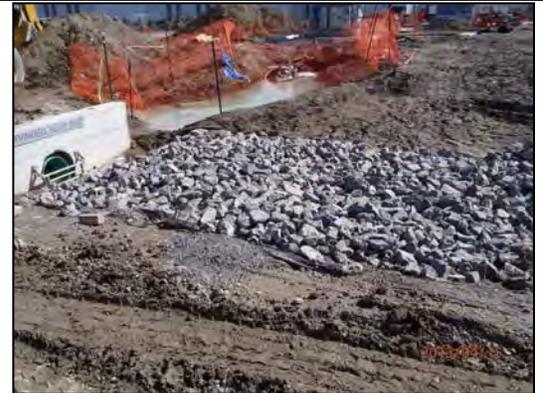
Photograph 70: Closer View of eastern interceptor swale on April 15, 2013

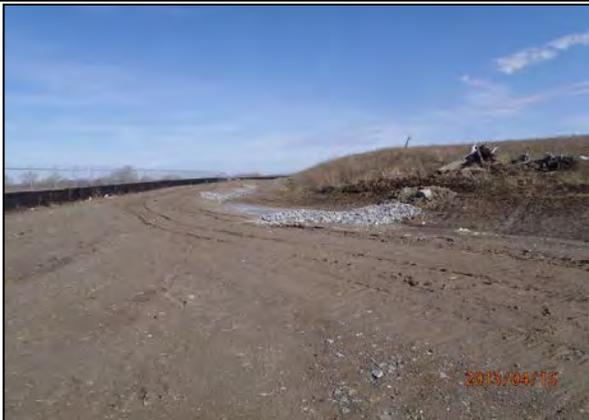
Photograph 71: View of western interceptor swale on April 15, 2013

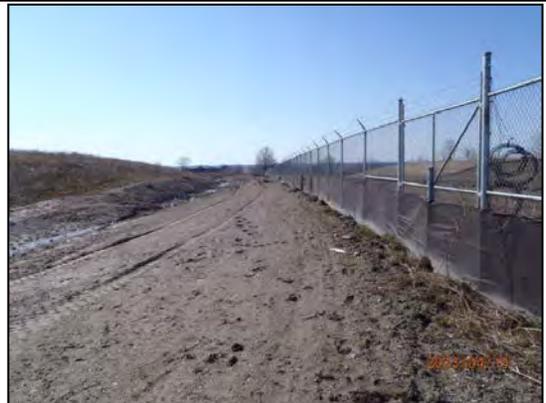
Photograph 72: View looking south capturing western perimeter silt fence and interceptor swale on April 15, 2013
