**THIRD PARTY INDEPENDENT AUDIT
DURHAM YORK ENERGY CENTRE FACILITY
OPERATIONS PHASE AUDIT - 2019**

Project Number: 180225
September 25, 2020

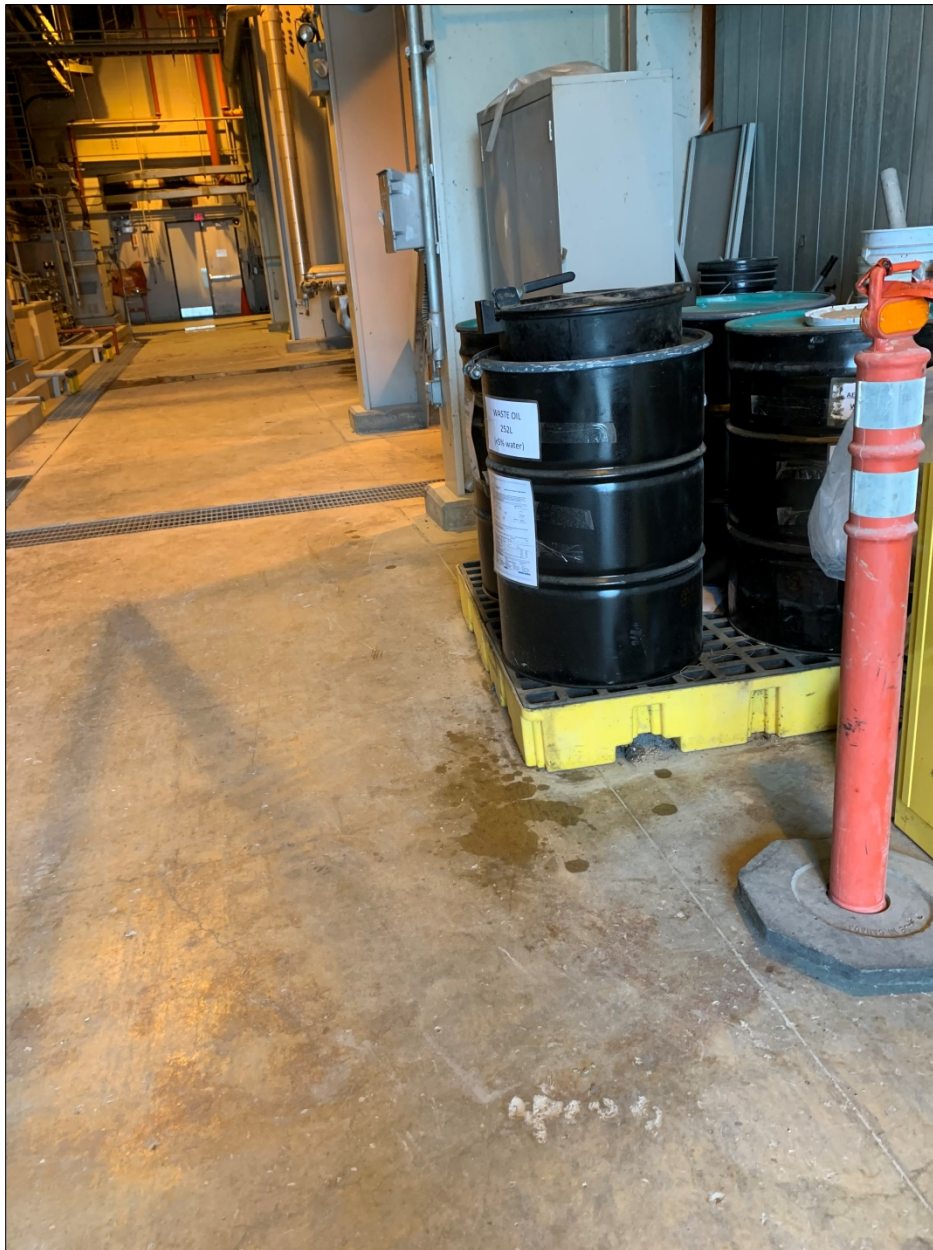
Photograph of Waste Oil Drum Spill

Figure 1: During the virtual site visit, a small quantity of liquid was noted on the floor beside the waste oil drum. The above picture was provided to BluMetric following the audit and was taken after the liquid had been wiped up.
