Technical Memo

Project: Durham York Energy Centre (DYEC)

Subject: **Covanta Phase 1 Completion and Recommendation for Boiler #1 Restart**

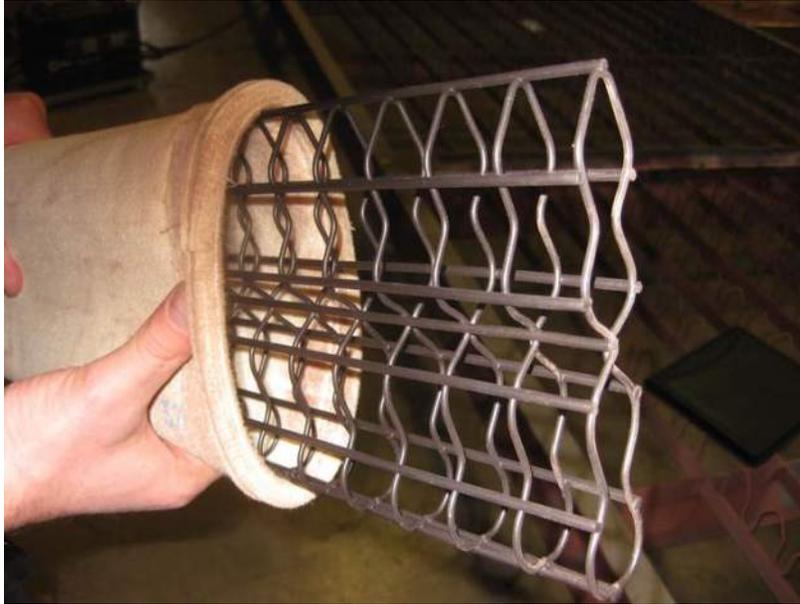
Photo 29 - Bag and Cage
