APPENDIX C

Site Photographic Record

Site Photographic Record (Selected Photos) - Durham-York Energy Centre Surface Water Monitoring Program - During Construction Year 1

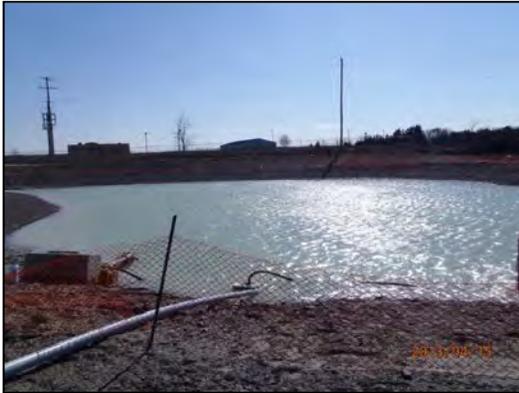
Photograph 67: View of East SWM Pond incl temp PVC outlet pipe on April 15, 2013

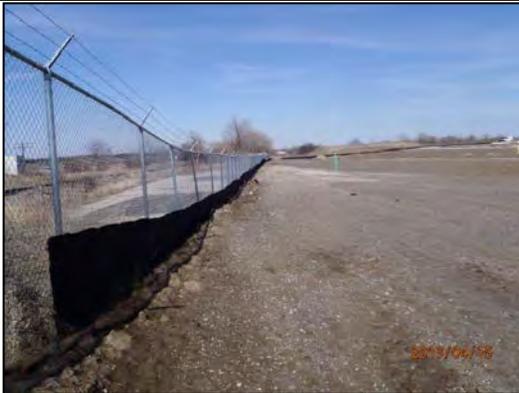
Photograph 69 View of southern perimeter silt fence on April 15, 2013
